Geotechnical Extreme Events Reconnaissance

July 22, 2014

The 22 March 2014 Oso Landslide, Snohomish County, Washington

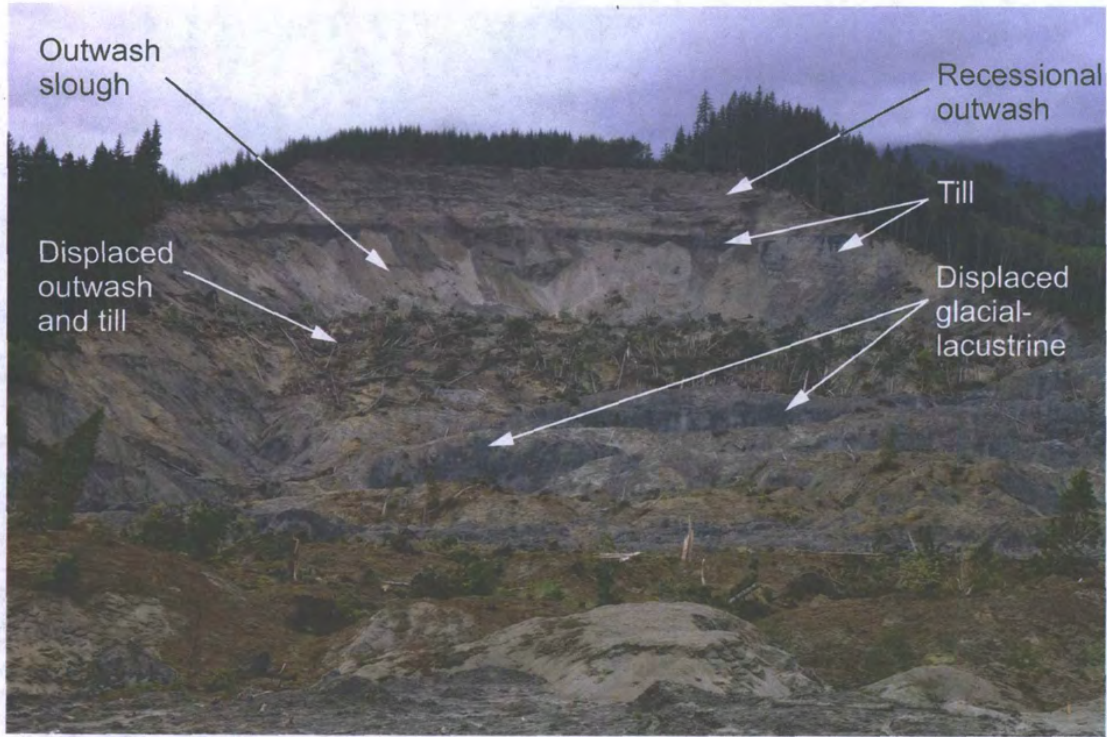
The stratigraphy of the landslide site is disrupted below the elevation of the “ancient headscarp” apparent on the 2003 hillshade image (Figure 2.2.2). But the undisturbed section now exposed in the 2014 landslide headscarp (Figure 2.2.3), together with exposures on the landslide lateral margins, indicates that the site geology consists of deposits that are typical of the sequence found throughout the Puget Lowland. [Note that “headscarp” in this report would be called “main scarp” by Cruden and Varnes (1996).]

Figure 2.2.3 View of Oso Landslide and geologic exposures in scarps.
Camera position: 48.27690°N, -121.83967°W; view direction: 327°.

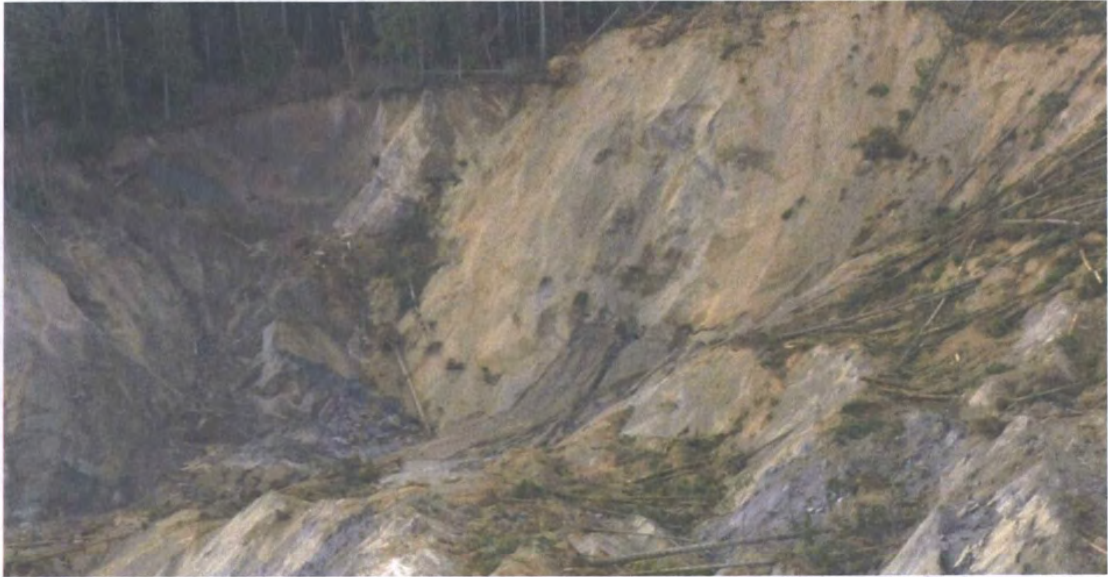
Figure 5.2.2. Seeps along western (right) margin of the landslide. Photo credit Eric Jensen, King County Sheriff Department, photo date 3/24/2014.

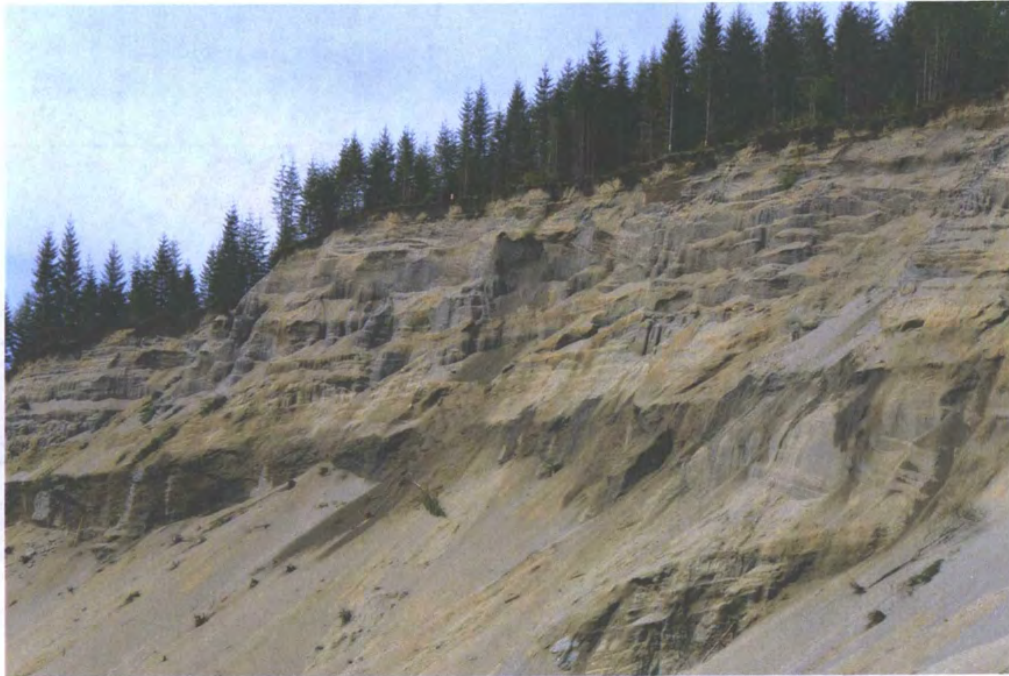
Figure 5.2.4 Photograph of Zone A1, recessional outwash and gray glacial till exposed in landslide headscarp.

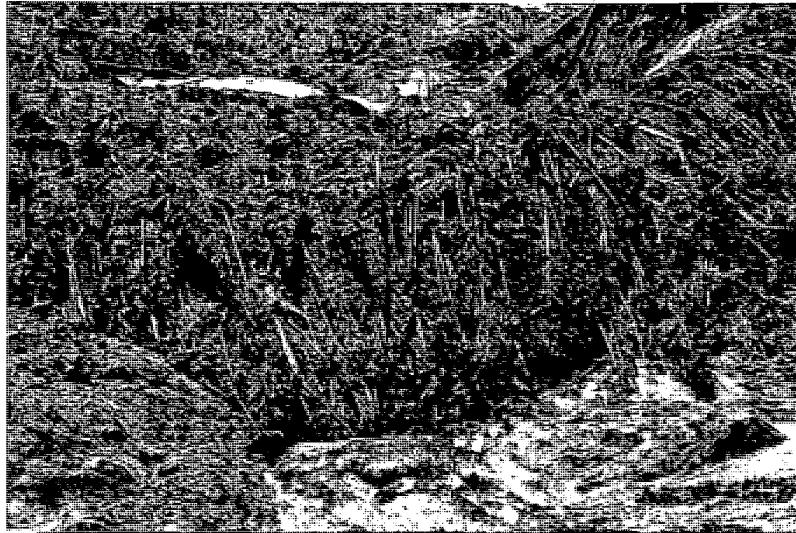
Figure 5.2.5a: Photograph of Zone A2 as seen from top of landslide headscarp; view to south. Note uniform back-rotation of trees and onlap of gray till fragments of Zone A4 from scarp-face failure at left.

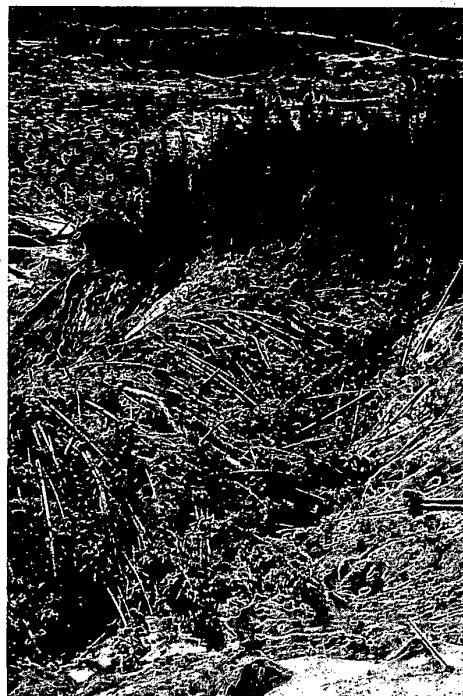
Figure 5.2.5b: Photograph of Zone A2 as seen from top of landslide headscarp; view to southwest. Note the topographic depression between Zone A2 (covered by downed trees) and Zone A1 (base of headscarp at right).

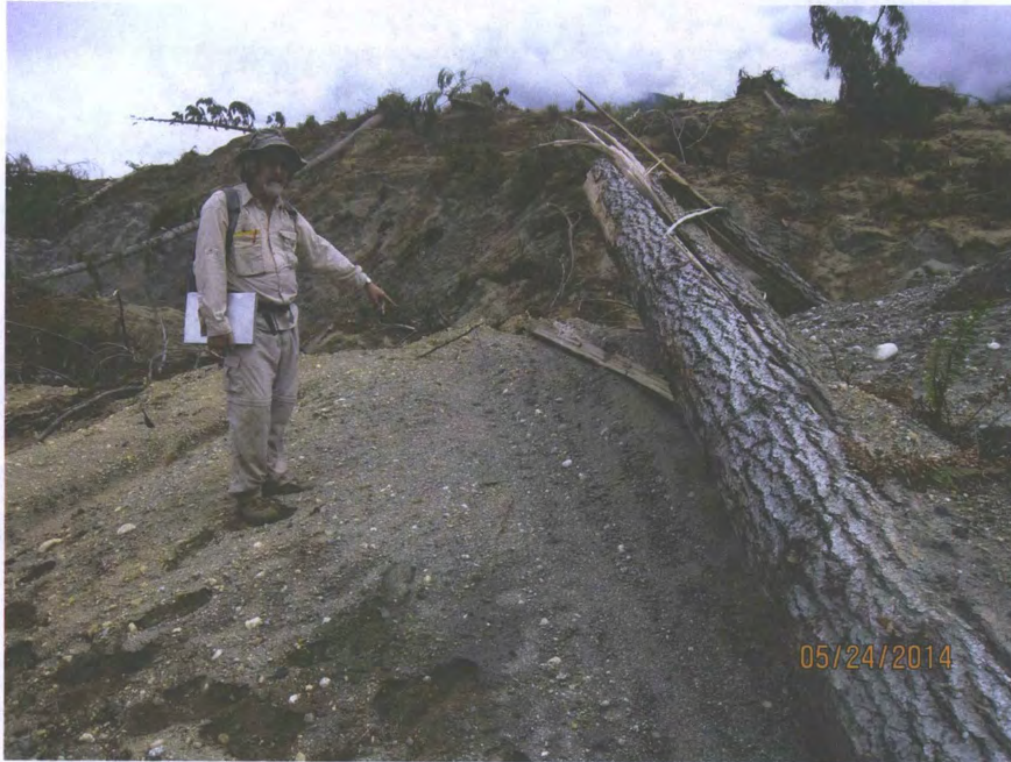
Figure 5.2.10c. pair of track-like impressions in the loose sand indicate that the log impacted violently and bounced before coming to rest. Photo taken by GEER on May 24, 2014. Camera position: 48.281458°N, 121.848316°W, view south.

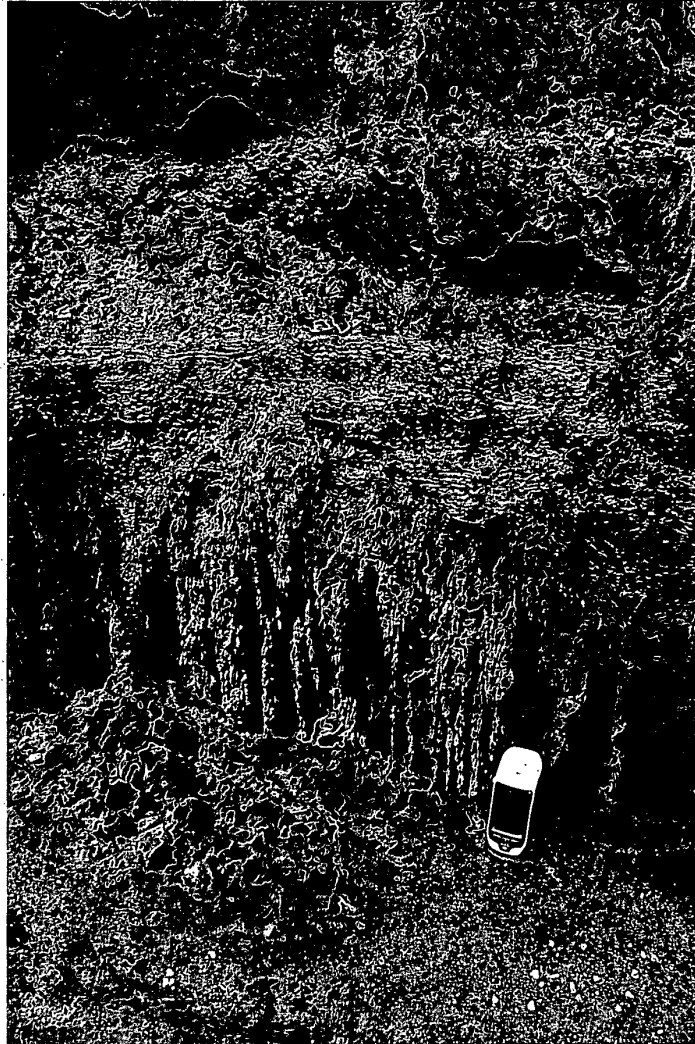
Figure 5.2.11: Lacustrine sediment exposed in western lateral margin in Zone B. Note flow structures running down from seeps in the outcrop face.

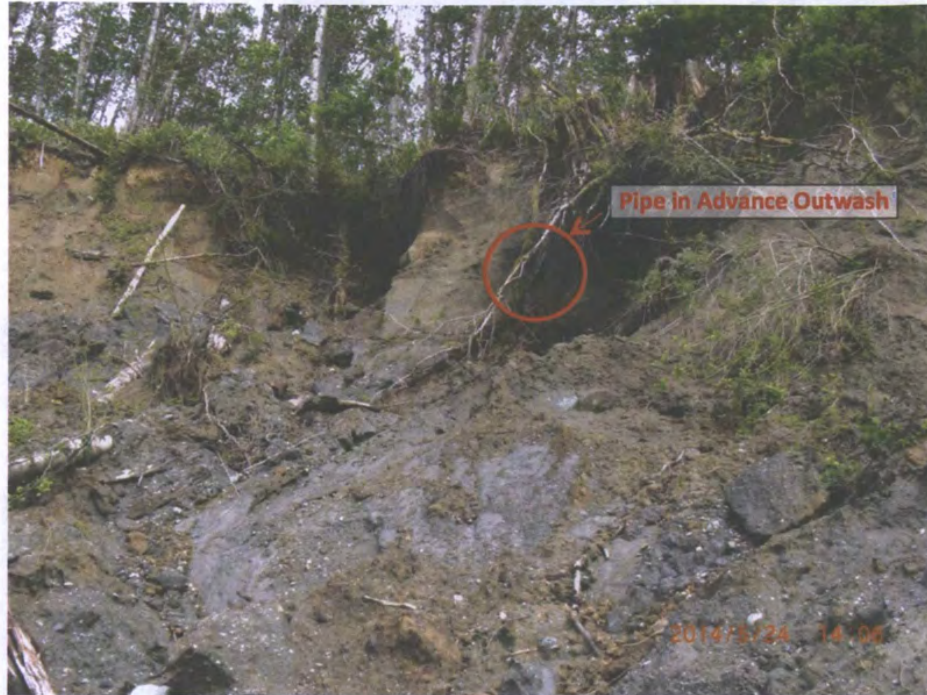
Figure 5.2.14 Seepage and piping near interface between Advance Outwash sand overlying Glacial Lacustrine clay. Location: N 48°17.124' W 121°50.827'; view looking east.

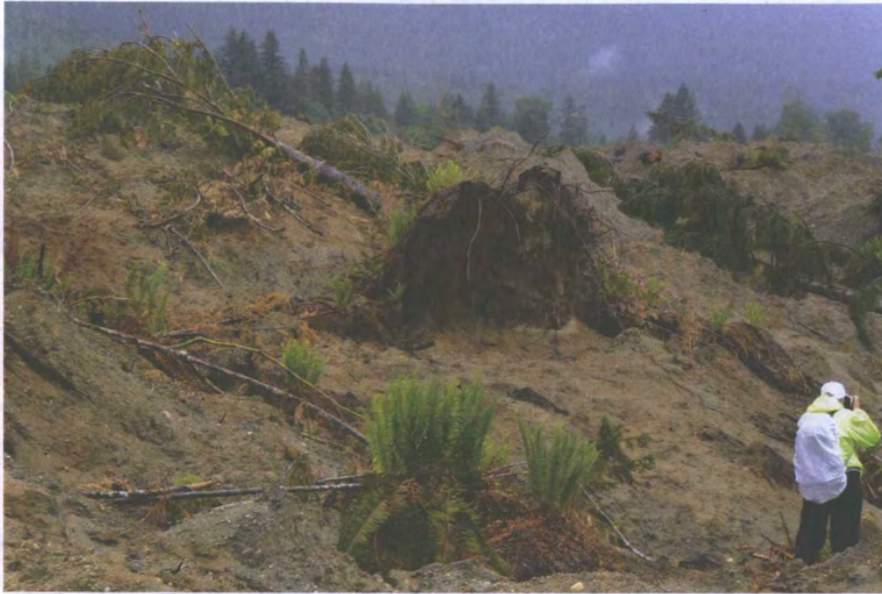
Figure 5.2.18 Preserved areas of intact forest floor in Zone E.

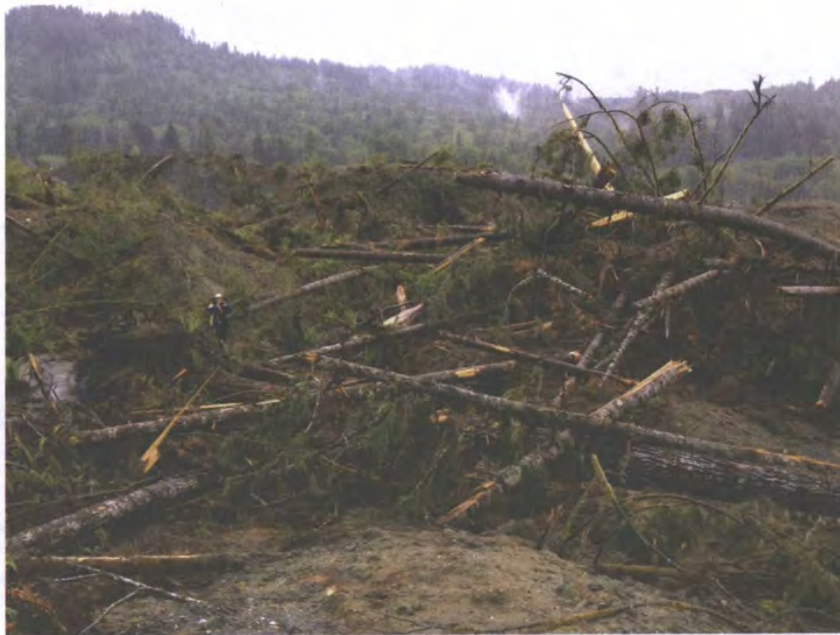
Figure 5.2.20 Tumbled and broken trees in the impact zone between Stage 1 and Stage 2. Camera position: 48.27897, -121.84609.

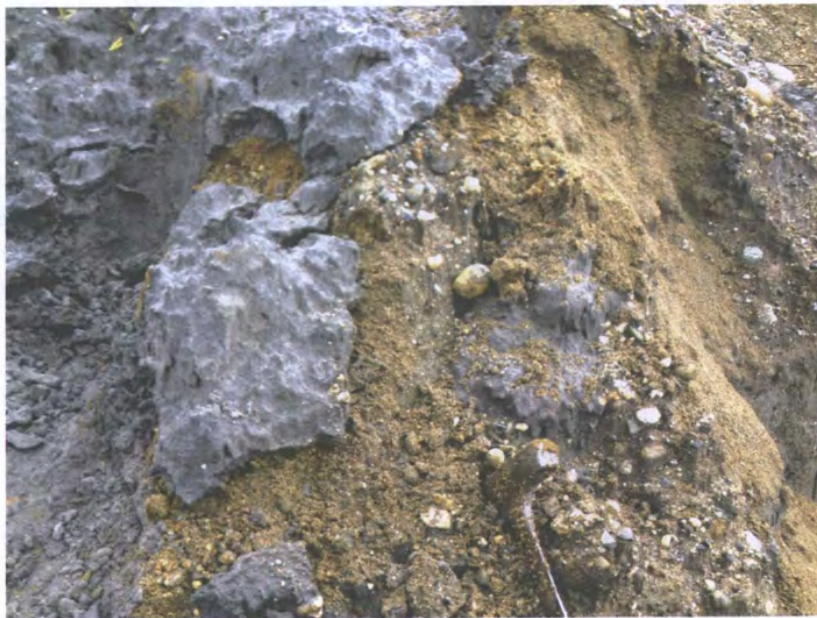
Figure 5.2.21 Typical gray veneer that appears to be a splash deposit. Head of rock hammer in bottom center for scale. Camera position: 48.27903, -121.84611.

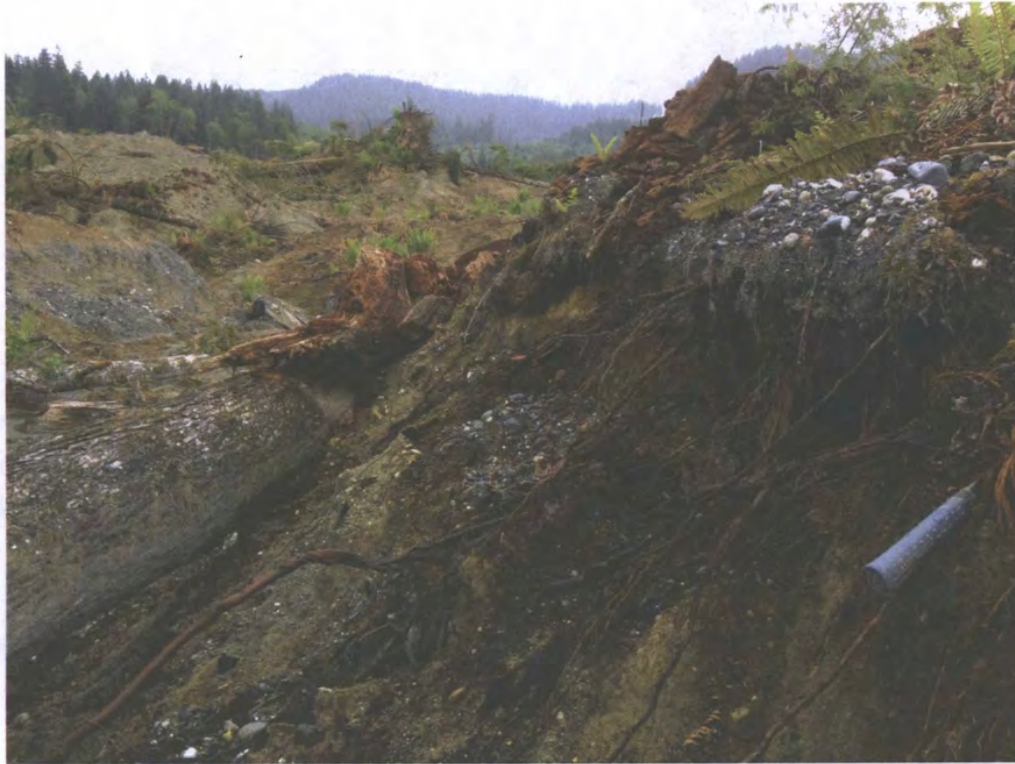
Figure 5.2.22 Gravelly and sandy silt veneer. Visible here on a remnant of the forest floor in the foreground, on a fallen tree towards the left of the photo, and coating the sandy bank of the basin in the background. This veneer-ringed basin appears to open only to the south, indicating flow to the north and thus a splash-back or flow reversal in the debris flow runout zone (i.e., from Zone F). Camera position: 48.27735, -121.84674, view south.

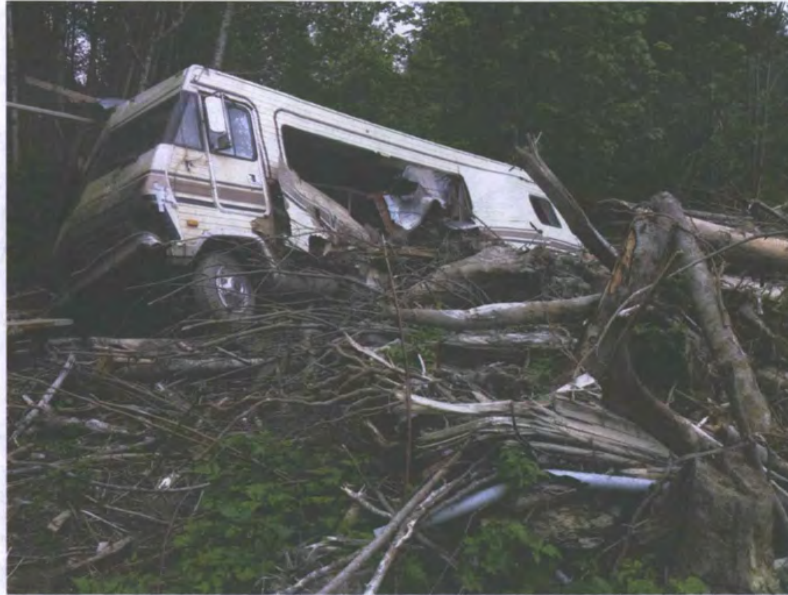
Figure 5.2.28 Recreational vehicle (RV) at the distal edge of the flow. Image shows damage to its side by a root-wad that is still present beside the vehicle. There is little evidence of earth debris: the RV was pushed and damaged by woody debris, as if carried by a flood. Camera position: 48.27528, -121.84160.

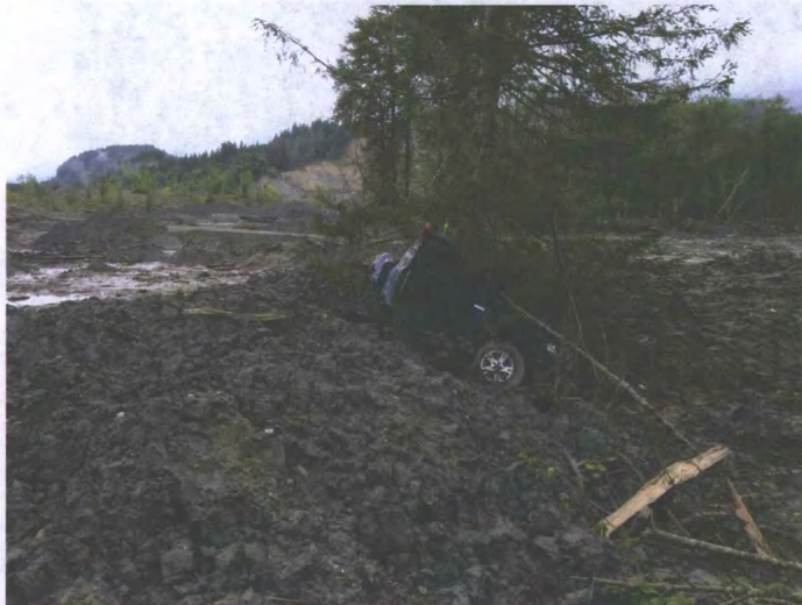
Figure 5.2.29 Vehicle wrapped around tree as if pushed from the southwest. The landslide source area is to the northwest and is visible in the background. Camera position: 48.27871, -121.83420.

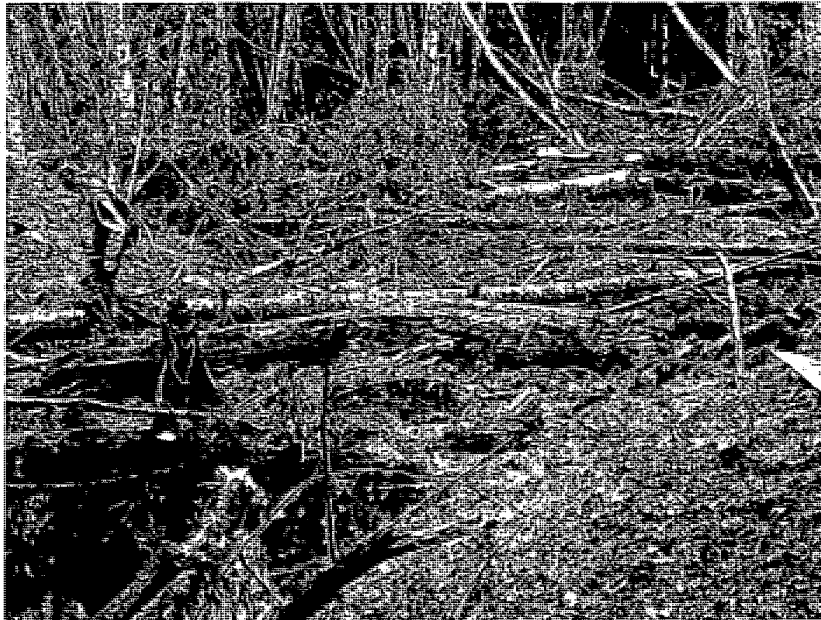
Figure 5.2.30 Log that formed part of the log revetment constructed after the 2006 landslide and found in distal portion of Zone F (note steel cables). Photo taken on May 23, 2014; Camera position: 48.27912°N, 121.83592°W, view toward the northeast.
