Landslide of the Week – Aldercrest Banyon Landslide

Aldercrest Banyon Landslide, Cowlitz County

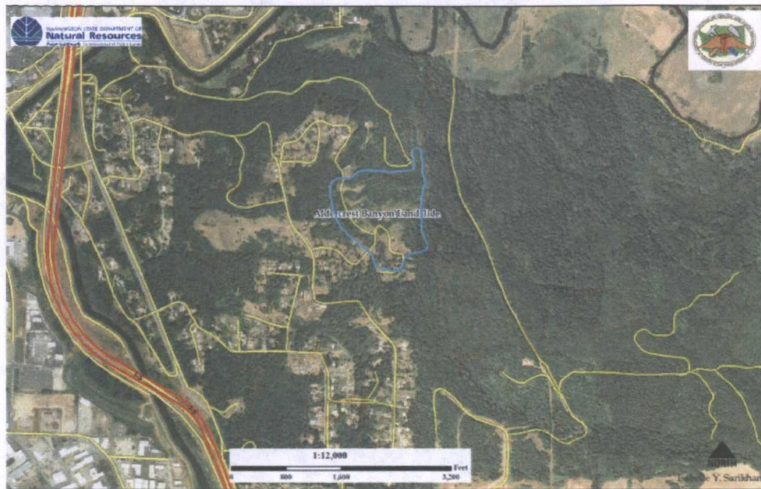
Aldercrest Banyon Landslide Map

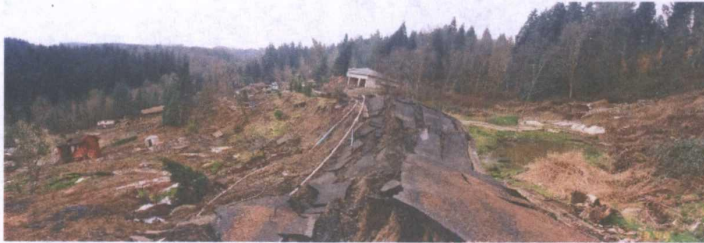
Photo of landslide damage, Photo from Dr. J David Rogers

“The Aldercrest-Banyon neighborhood in eastern Kelso, Washington began experiencing gross ground movements in February 1998, following 3-1/2 years of above-average rainfall. The initial signs of distress were the breakage of underground utilities. In March 1998 some framing distress was noted on a few homes. On April 10, 1998 a noticeable crack, 2.5 to 6 feet high, developed above the natural crest of slope west of Banyon Drive and north of Cedar Glen Court. Two homes on Cedar Glen Court were evacuated. The City made a valiant effort to patch streets, fill cracks and provide above-temporary above-ground utilities to the affected neighborhoods so that people could remain in their homes as long as possible.”

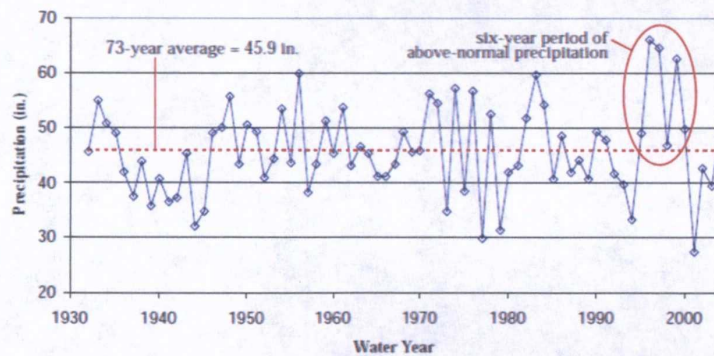
Rainfall Rates for the Cowlitz County Area, from DGER RI35

Karl Wegmann (who was a landslide geologist here at the Washington Geological Survey) states in his publication that 6 years of increased rainfall correlates to a period of increasing landslide activity (Wegmann, 2006). Others reduce this somewhere between 2-4 years of increased precipitation. As a friend of mine would ask about now, but there are many areas of above normal rainfall on the graph, why this time, why this event? We might want to look at when the housing district first was established in this area. The housing development was in full swing in the area in 1975-76 with what I suspect is a
