Geotechnical Extreme Events Reconnaissance

July 22, 2014

The 22 March 2014 Oso Landslide, Snohomish County, Washington

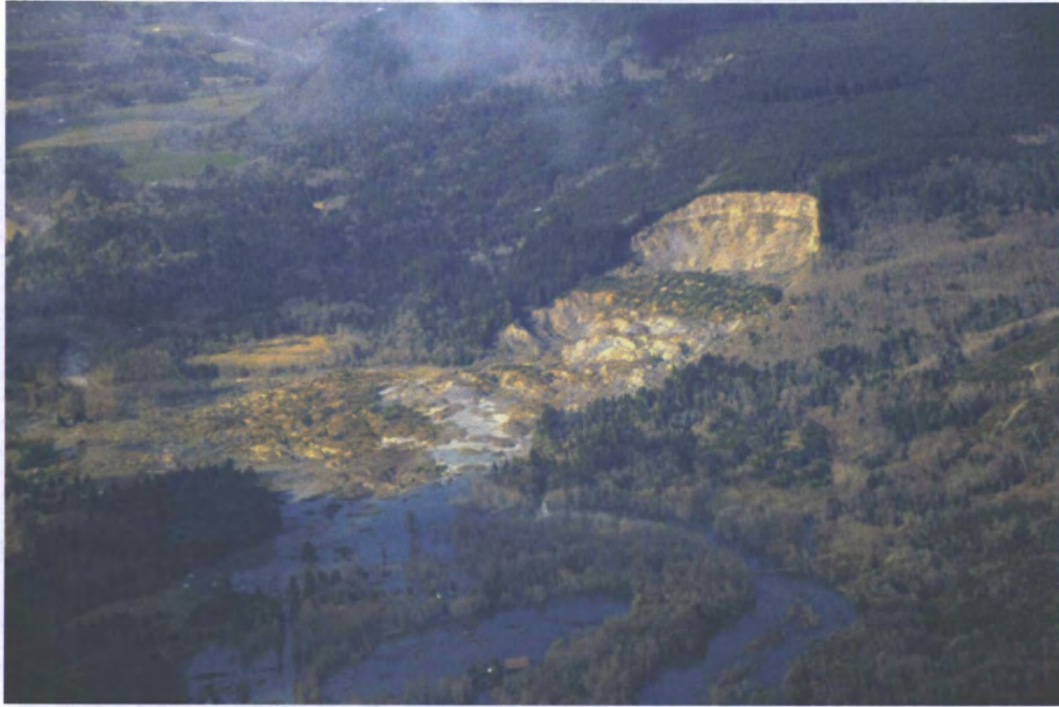
Figure 1.2 The 22 March 2014 Oso, Washington Landslide (photograph courtesy of the Washington Dept. of Transportation)

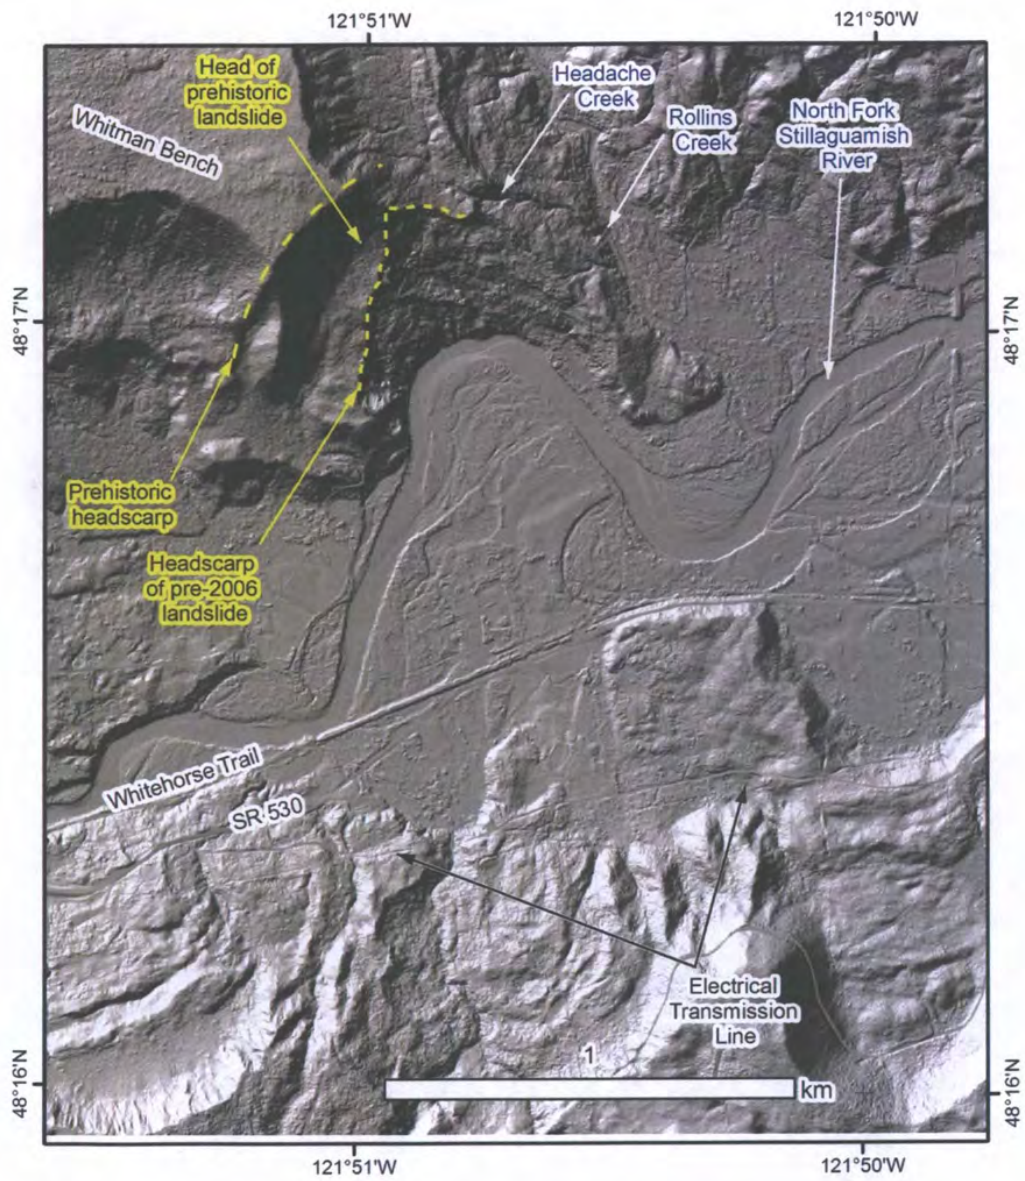
The stratigraphy of the landslide site is disrupted below the elevation of the “ancient headscarp” apparent on the 2003 hillshade image (Figure 2.2.2). But the undisturbed section now exposed in the 2014 landslide headscarp (Figure 2.2.3), together with exposures on the landslide lateral margins, indicates that the site geology consists of deposits that are typical of the sequence found throughout the Puget Lowland. [Note that “headscarp” in this report would be called “main scarp” by Cruden and Varnes (1996).]

Figure 2.2.2 Hillshade map of 2003 ground conditions. Base image from 2003 lidar data.

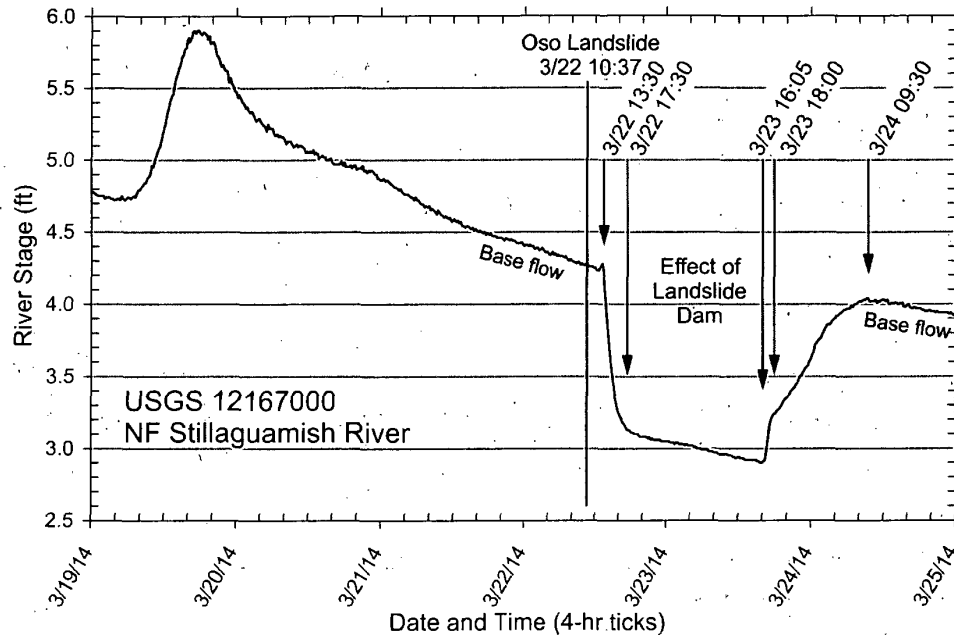
The detailed times associated with changes in river stage listed in Figure 3.3.3 show that a base flow condition returned albeit at a lower stage, at about 5:30 PM on 22 March and persisted for nearly 23 hours before an abrupt rise in river stage occurred. The abrupt rise in stage moderated at 6:00 PM on 23 March. Flow across the landslide appears to have been essentially recovered by

Figure 3.3.3 North Fork Stillaguamish River stage showing effects of Oso Landslide dam.
 Plotted from data obtained from USGS website
http://waterdata.usgs.gov/wa/nwis/uv/?site_no=12167000

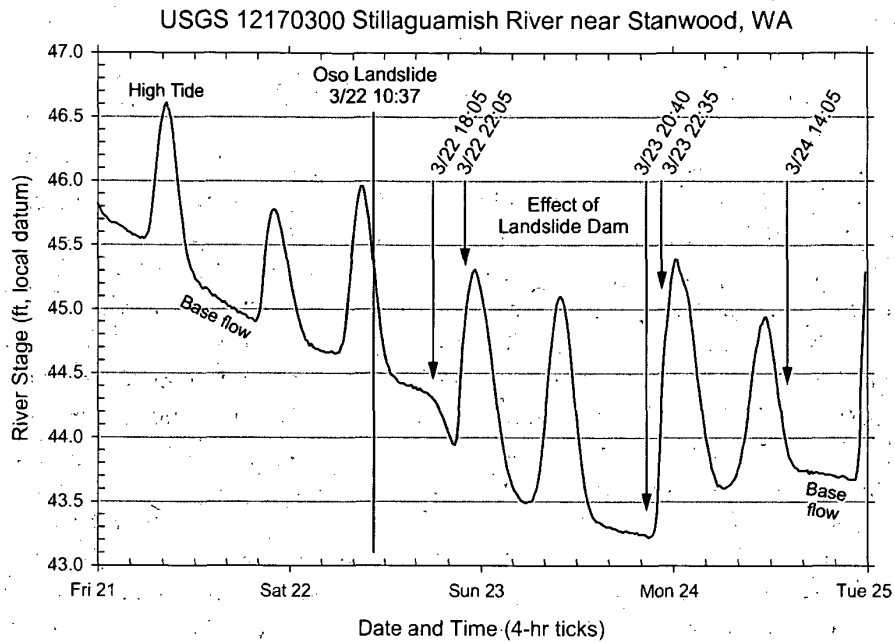
9:30 AM on 24 March. The USGS reported that the drop in river stage amounted to a reduction in discharge of about 34 cms (1200 cfs) (online report at http://www.usgs.gov/blogs/features/usgs_top_story/landslide-in-washington-state/). A stream gauge downstream from Arlington on the Stillaguamish River (USGS 12170300) in the range of tidal influence also recorded the effect of the Oso Landslide dam (Figure 3.3.4).

Figure 3.3.4 Stillaguamish River stage showing effects of Oso Landslide dam and tidal influence from Puget Sound. Plotted from data obtained from USGS website http://waterdata.usgs.gov/wa/nwis/uv/?site_no=12170300.

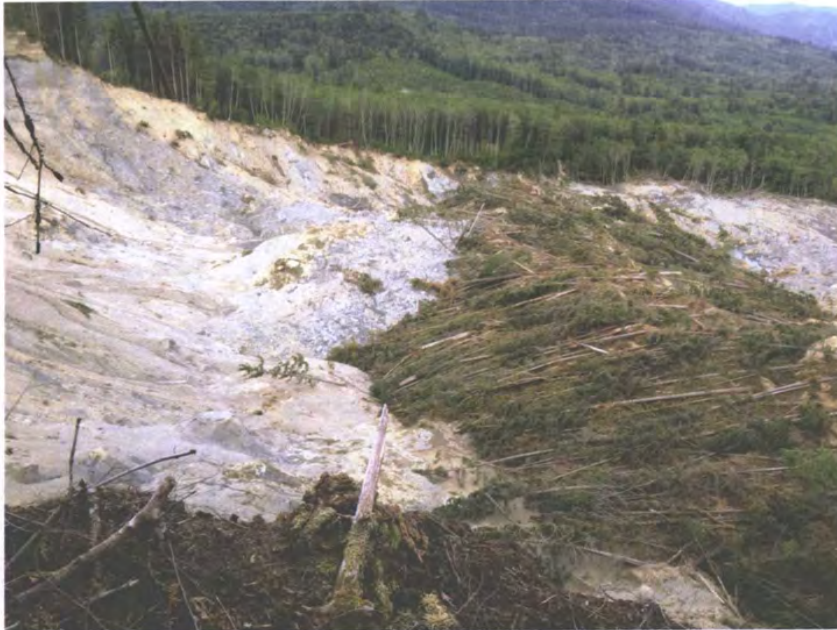
Zone A4 consists of a scarp-face failure in which till fragments and overlying recessional outwash material collapsed onto and over-rode a portion of the slump block that forms Zone A2 (Figure 5.2.6). Other failures off the headscarp have started to infill the closed depression (moat or graben) on the upslope side of Zone A2 at the base of Zone A1 with loose debris eroded from the over-steepened scarp face, rapidly smoothing the sharp, angular features of the headscarp as the moat fills with talus.

Figure 5.2.6 Onlap of gray till in Zone A4 over eastern portion of the downed-tree-covered slump block of Zone A2 (back-rotated slump block); view east from 48.27073, -121.84038.

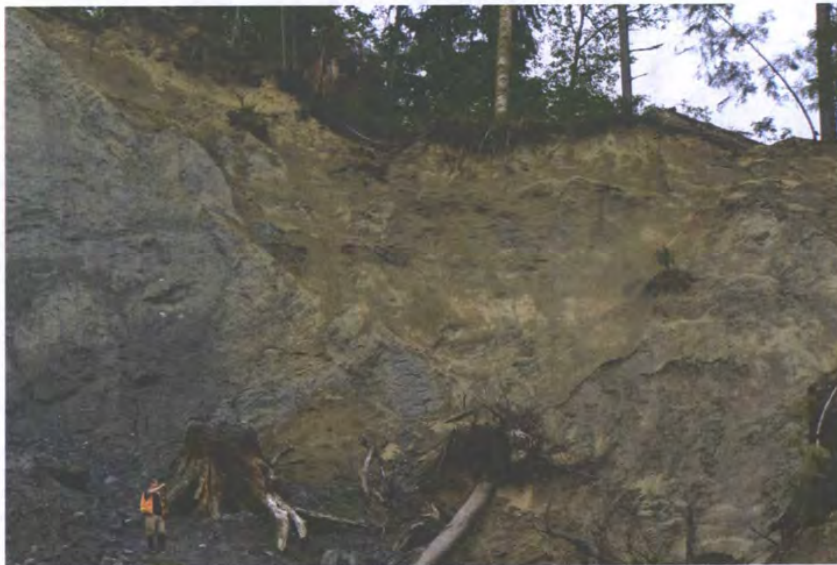
Figure 5.2.7 Photograph of the eastern margin of Zone A; view toward northeast. Note exposure of in-place till (gray at left) with steep contact (prehistoric landslide scarp) running from upper left corner of photo to lower middle. Sandy oxidized talus in middle and upper right buries log sampled for 14C dating (see Table 5.3.1, sample Oso3).

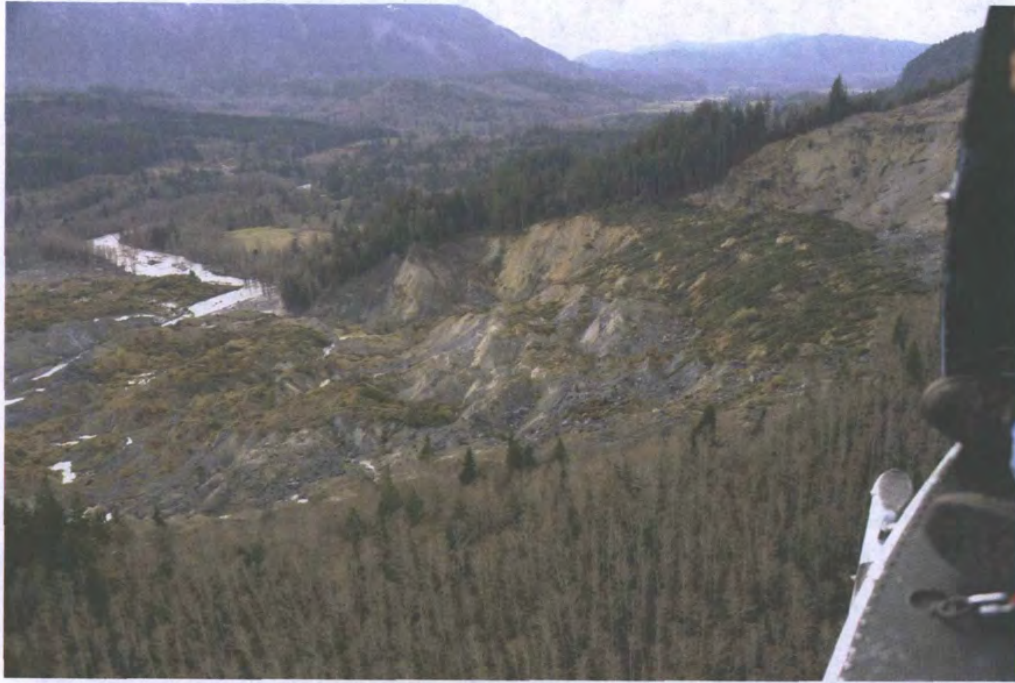
Figure 5.2.8 Rotational block field of Zone B seen from the air looking west. Photo credit Eric Jensen, King County Sheriff Department, photo date 3/24/2014.

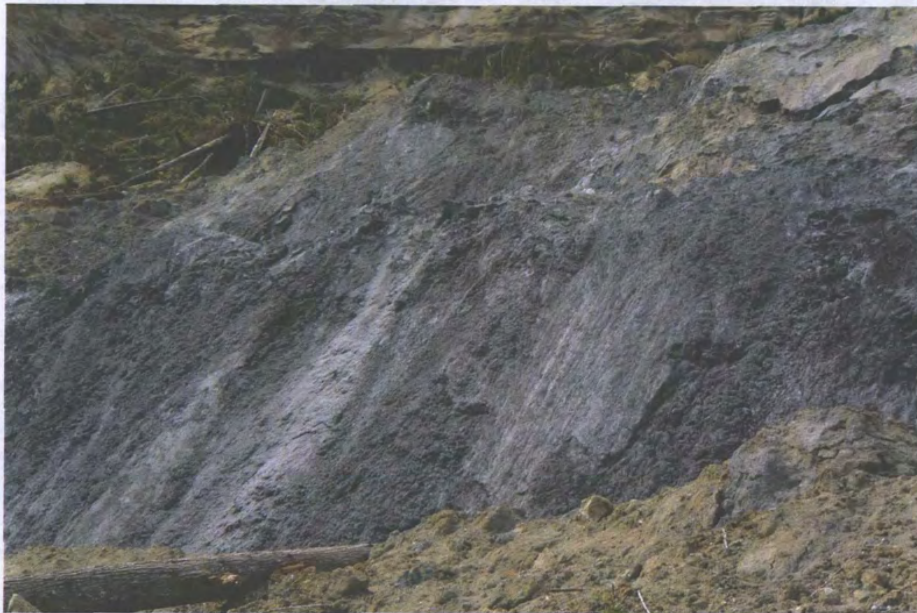
Figure 5.2.9: Zone B slickensides in lacustrine clay.

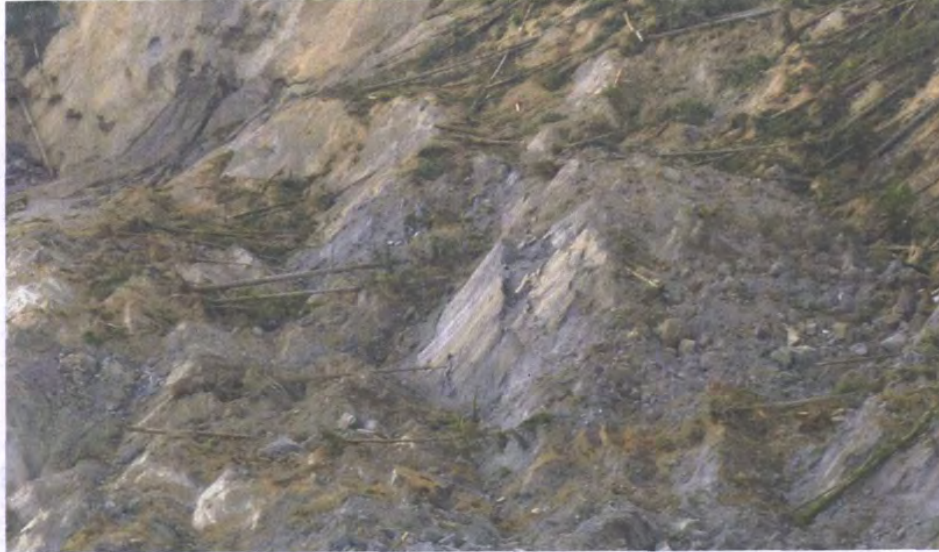
Figure 5.2.10a. Oblique view of two approximately 100-ft-long (30 m) fallen trees (near the center of the image) that have been dragged downslope after they were felled. They indicate the extension in this part of the slide mass. Photo by Eric Jensen, King County Sheriff Department, photo date 3/24/2014.

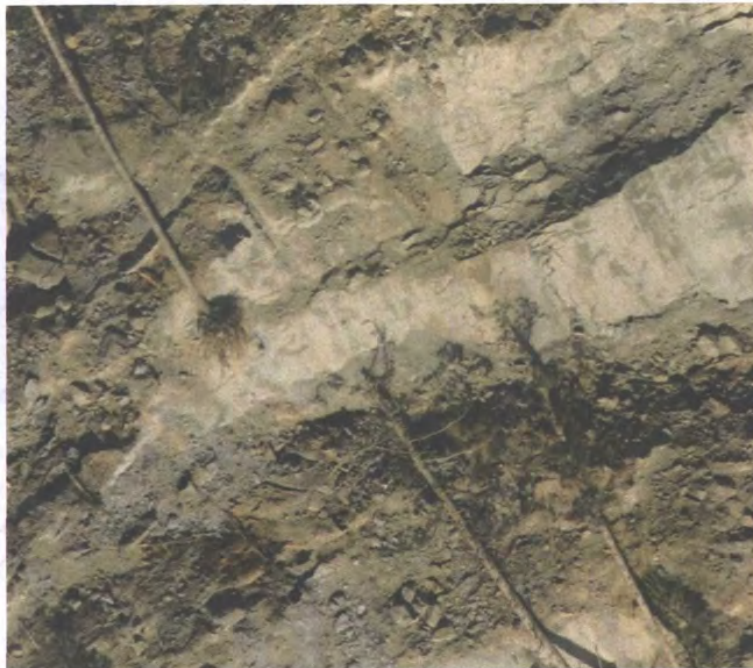
Figure 5.2.10b. Aerial view of indicator trees showing trails at least (45 m) 150 ft long showing skid marks from dragging. Location 48.28332, -121.84838. Aerial image dated 3/24/14 was provided by WSDOT GeoMetrix Office.

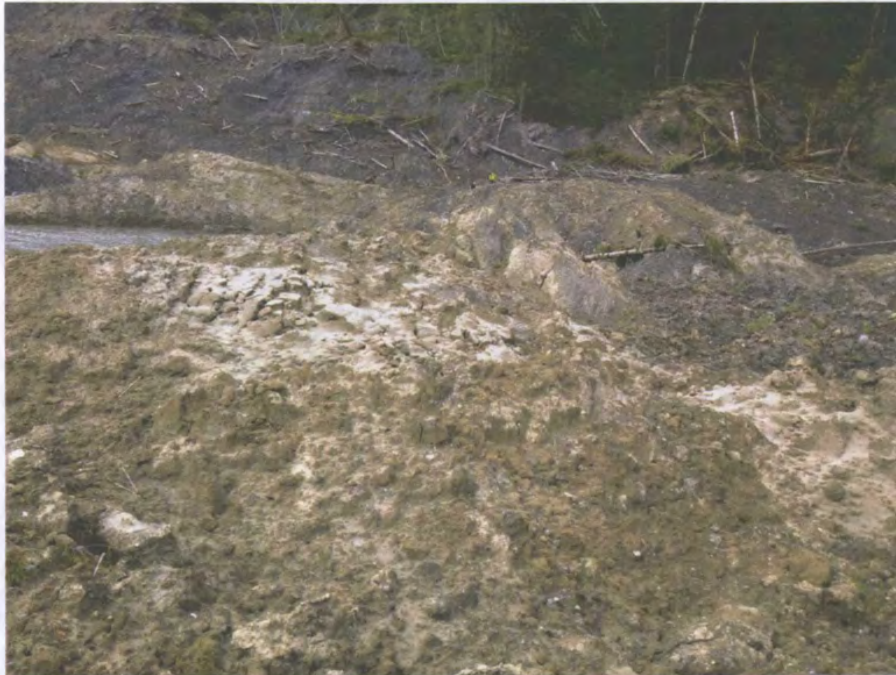
Deposits that are herein called sand ejecta (Figure 5.2.12) were observed in Zone B (and in Zone E). Sand ejecta deposits may be another expression of the same phenomenon as a sand boil (see

Zones E and F) – confined elevated water pressure and liquefaction of susceptible soils at depth. The sand ejecta deposits were not observed in low spots, but rather in what appear to be compression ridges. They appear to represent ejection by water of sand from cracks as the mass was emplaced. Sand ejecta deposits are not typically associated with earthquake-induced liquefaction and their mechanism of origin on the Oso Landslide is not as confidently understood as the sand boils. The fact that they were generally observed on higher ridges suggests that they could be associated with the thrusting upward of the ridges. Sand ejecta deposits were observed near the Zone B-Zone C interface.

Figure 5.2.12 View looking northeast at sand ejecta deposits in Zone B near the Zone C interface. Camera position: 48.28238, -121.84391.

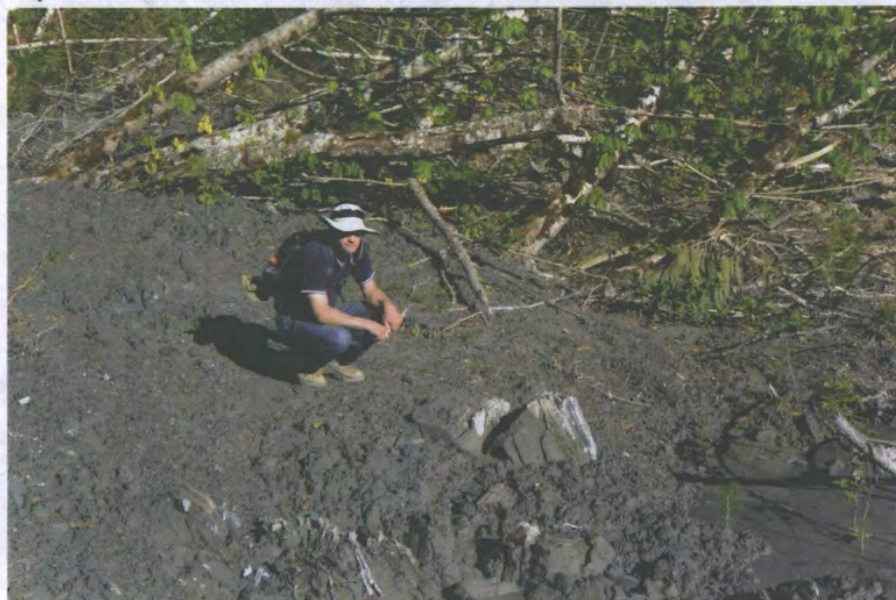
Figure 5.2.13A Liquefied lacustrine sediments in Zone C. Note rafted block of material set in flow matrix.

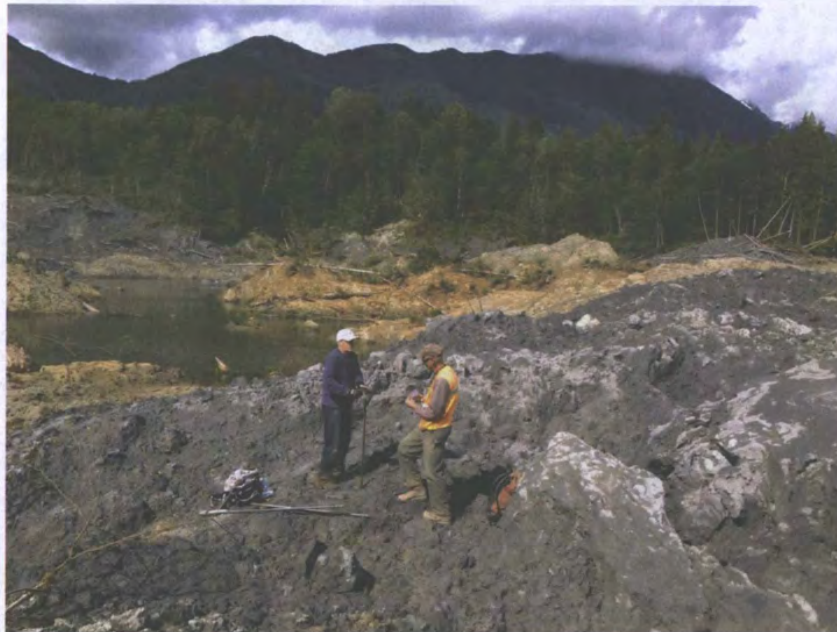
Figure 5.2.15: Hand auger boring (HA-3) into lacustrine material on the northern margin of Zone D. Camera location: 48.28118, -121.84519; view to northeast.

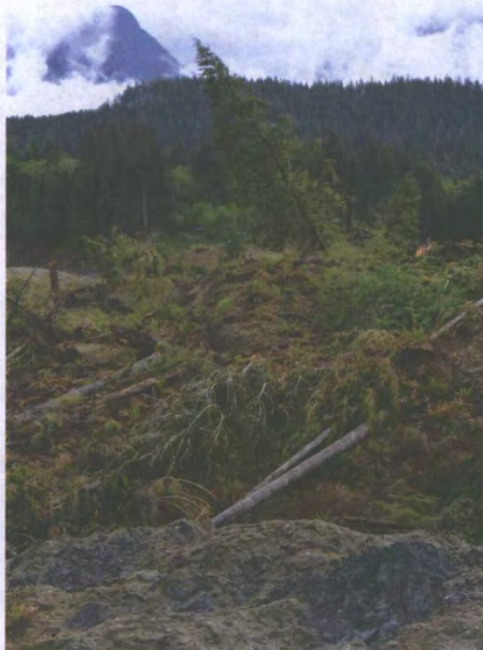
Trees on the surface of Zone E are both coniferous and deciduous. The coniferous trees are at the northern part of the zone and are dropped in various orientations, with some remaining subvertical (Figure 5.2.19). Large trees, with one observed to be >1.5 m in diameter, occur along the northern margin of the western portion of Zone E. Along this edge of Zone E (the northern

Figure 5.2.19 Tilted subvertical trees in Zone E.

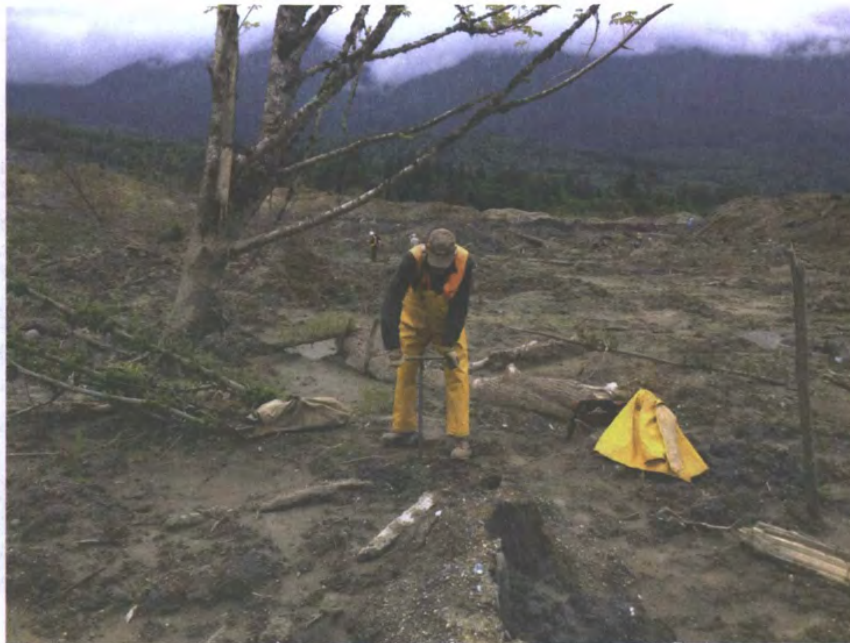
Figure 5.2.23 Sub-vertical tree rafted into current location near HA-10. Camera position: 48.27503, -121.84315, view northeast.

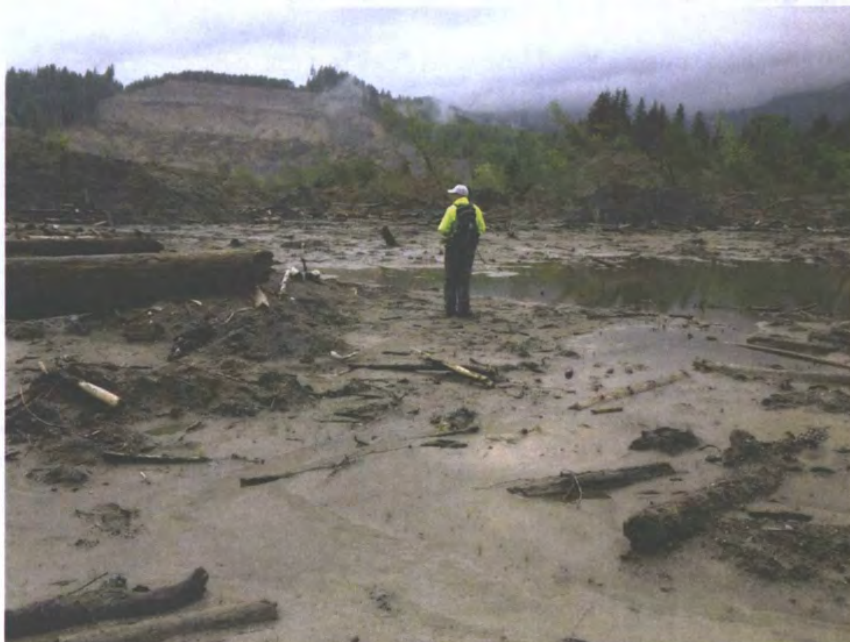
Figure 5.2.24 View from north end of Zone F toward rafted deciduous trees in Zone E, in background. Camera position: 48.27781, -121.83851.

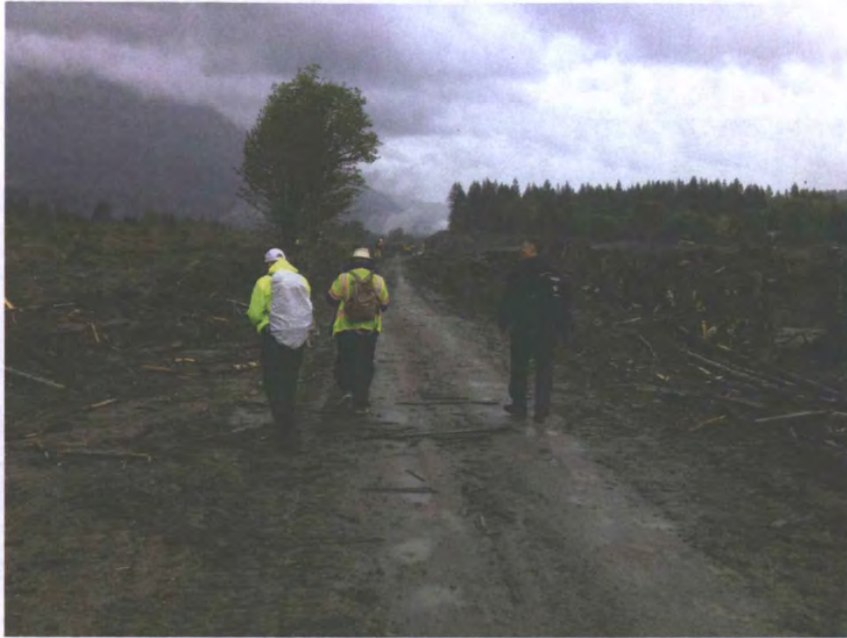
Figure 5.2.25 Maple trees north of SR 530 that appear to be in place. Camera position: 48.27521, -121.84814.

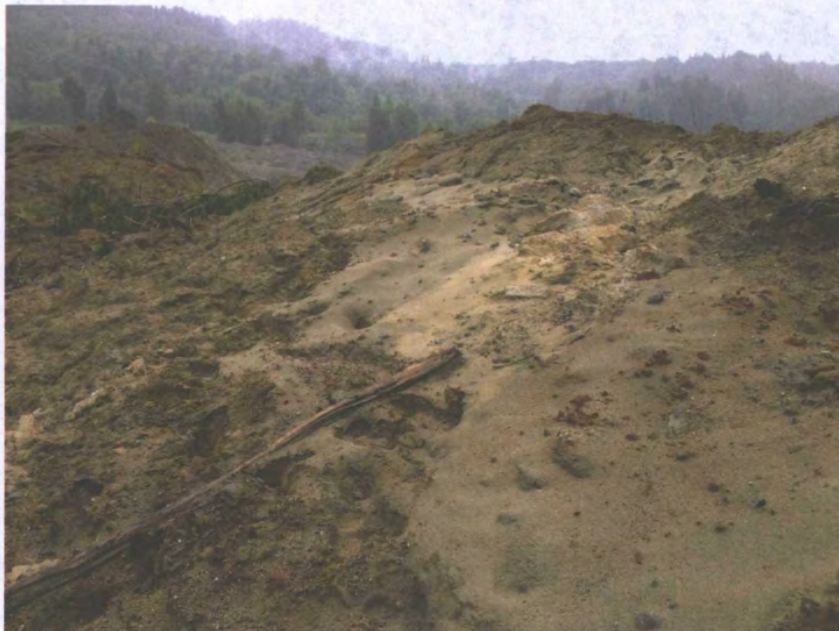
Figure 5.2.26 Typical sand ejecta deposit. Camera position: 48.27849, -121.84406.

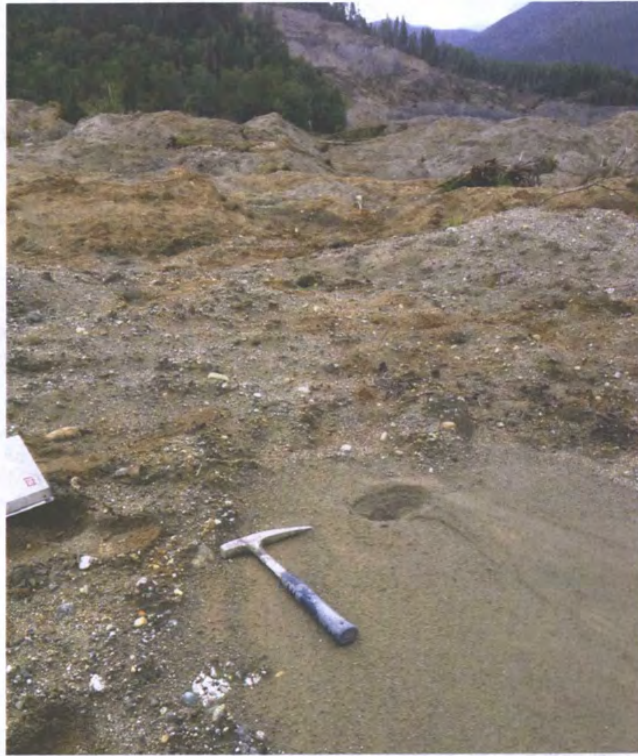
Figure 5.2.27 Typical sand boil. Location: 48.27616, -121.84686.

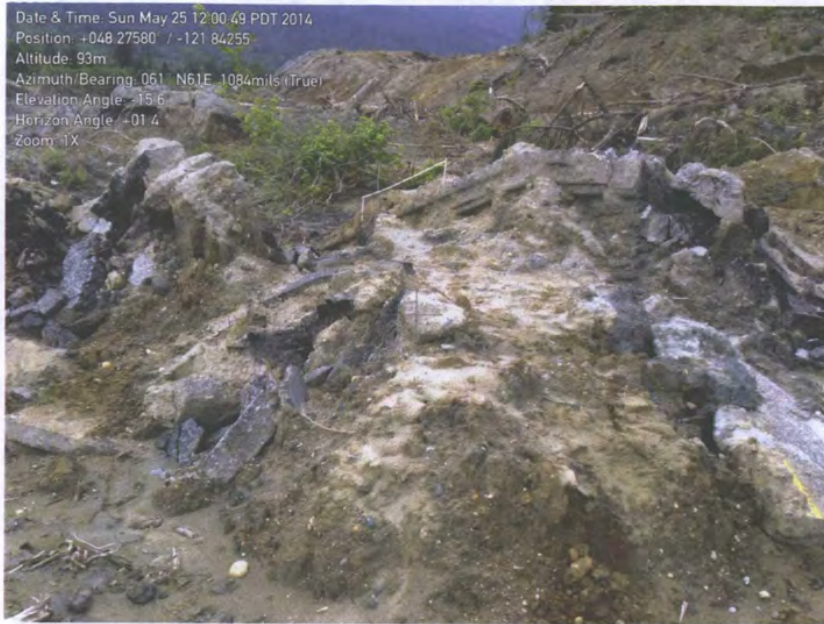
Figure 5.2.32 Asphalt with intact base course from SR 530 road bed plucked and transported by the debris flow. Note piece of asphalt in lower right with yellow paint stripe. Camera position: 48.27580°N, 121.84255°W, view to the northeast.

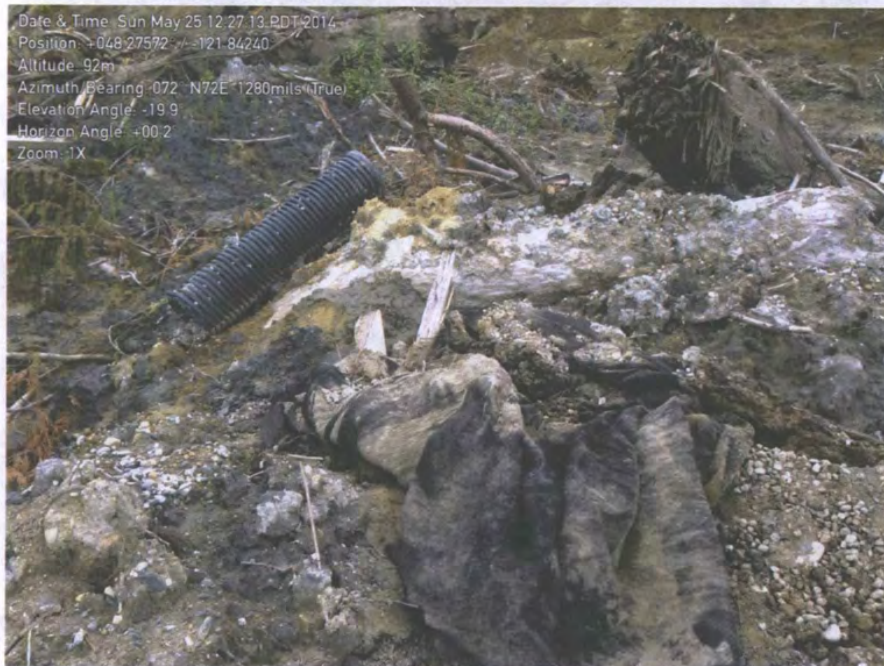
Figure 5.2.33 Drainage pipe and filter fabric from SR 530 transported to the southwest by initial debris flow. Camera position: 48.27572°N, 121.84240°W, view looking east-southeast.

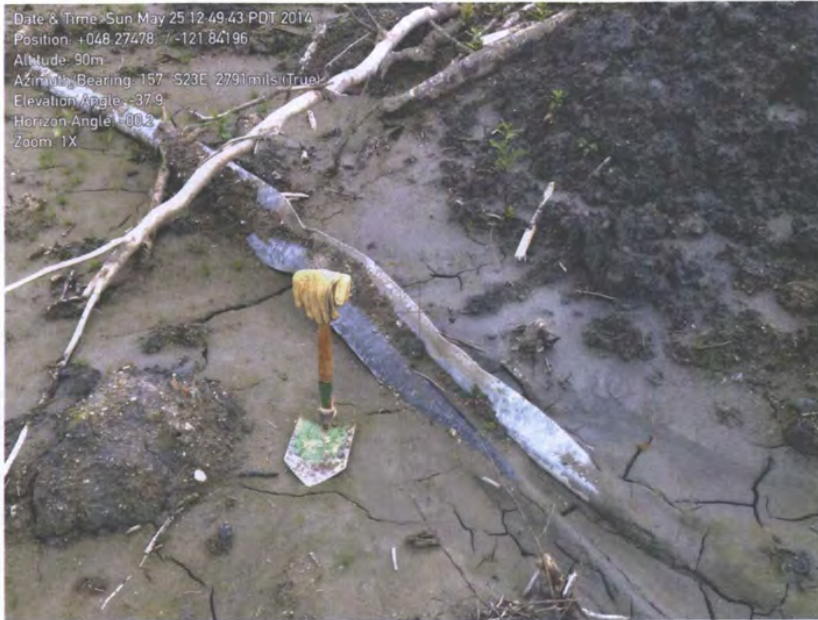
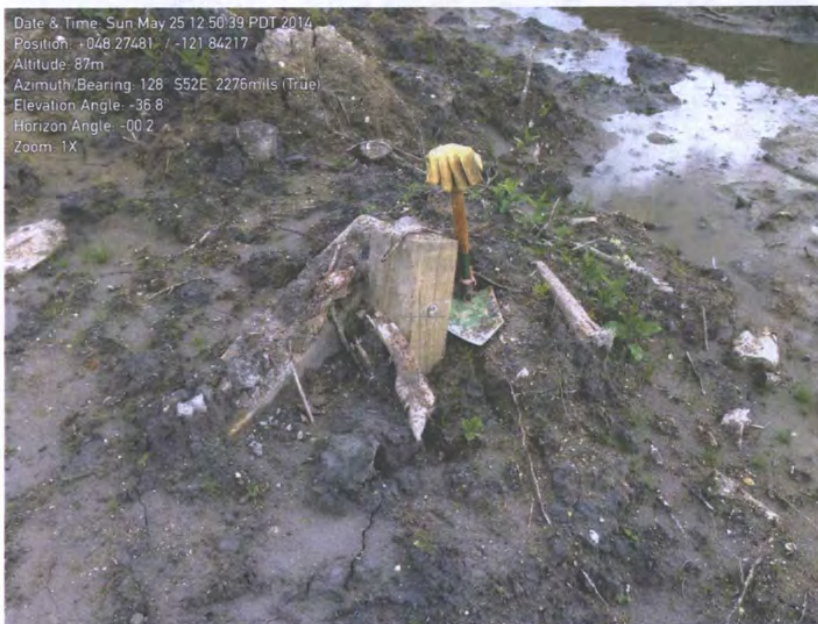
Figure 5.2.34. Section of guard rail (top) and timber support (bottom) transported from SR 530 by initial debris flow. Camera positions: 48.27478°N, 121.84196°W, view toward southeast (top); 48.27481°N, 121.84217°W, view toward southeast (bottom).

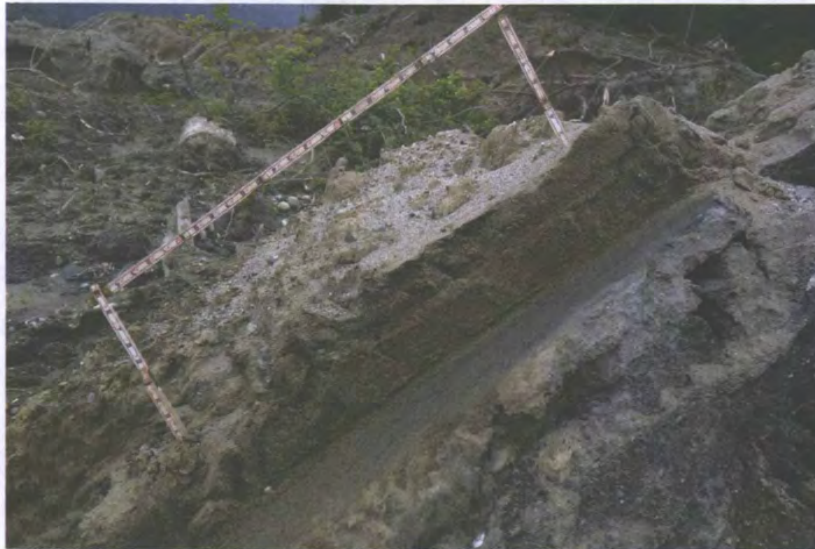
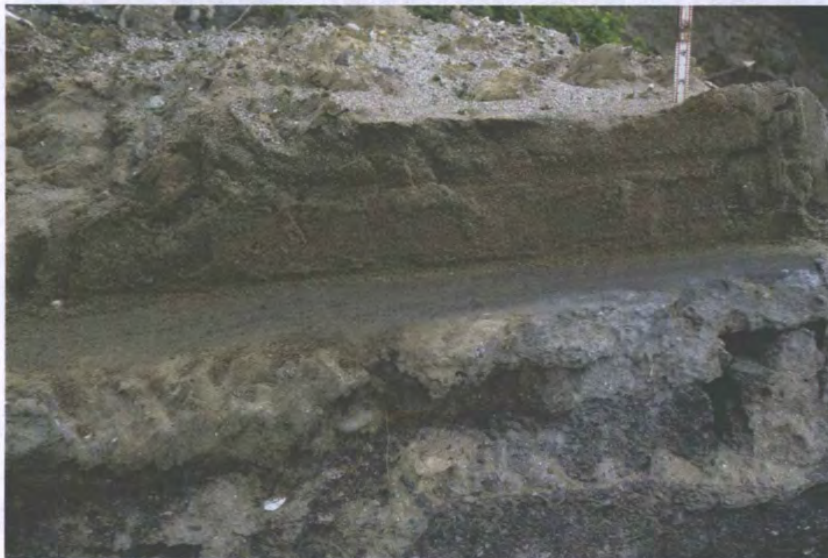
Figure 5.2.35. (upper) Example of one of several Highway 530 pavement sections that were uplifted and transported by the landslide. The pavement section (which is inclined down to the left) shows an intact segment of what is believed to be the first material to have crossed the highway prior to its subsequent uplifting and transport. The scale shown is in feet (location: -121.842560, 48.275860). (lower) Close view of the deposit above the pavement section. The photograph shows a course-grained tan sand over a thin (several mm) film of grey silt and clay over the asphalt. The pavement is underlain by a gravelly pavement base course material that was emplaced during construction of the road. The structure of the tan sand deposit suggests initial arrival of a hyper-concentrated flow rather than a debris flow.

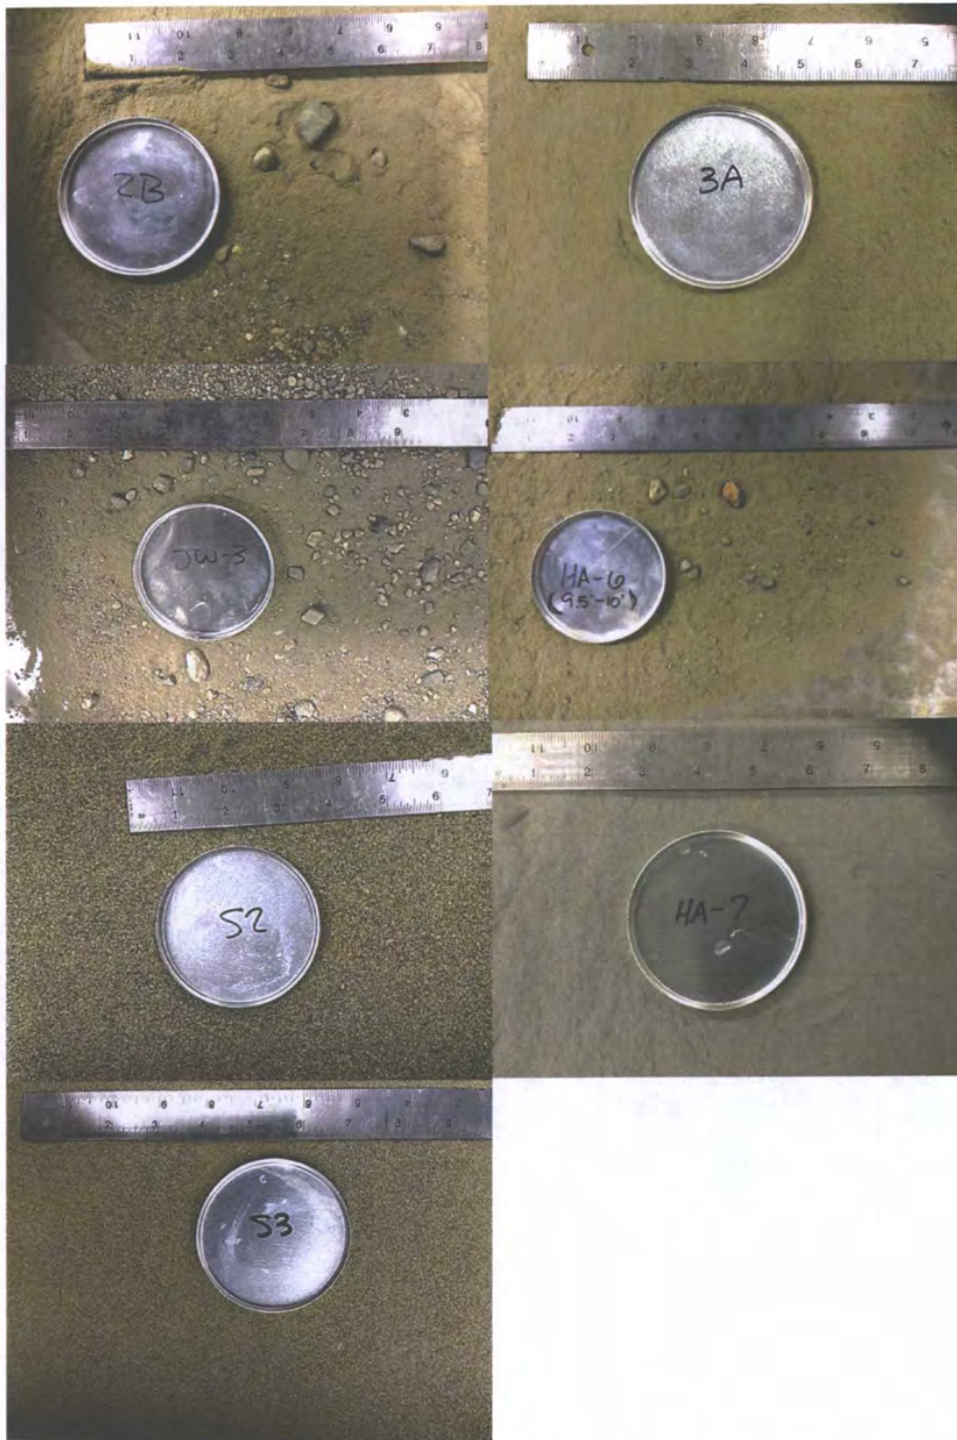
Figure 5.3.9 Photographs of dried and sieved specimens.

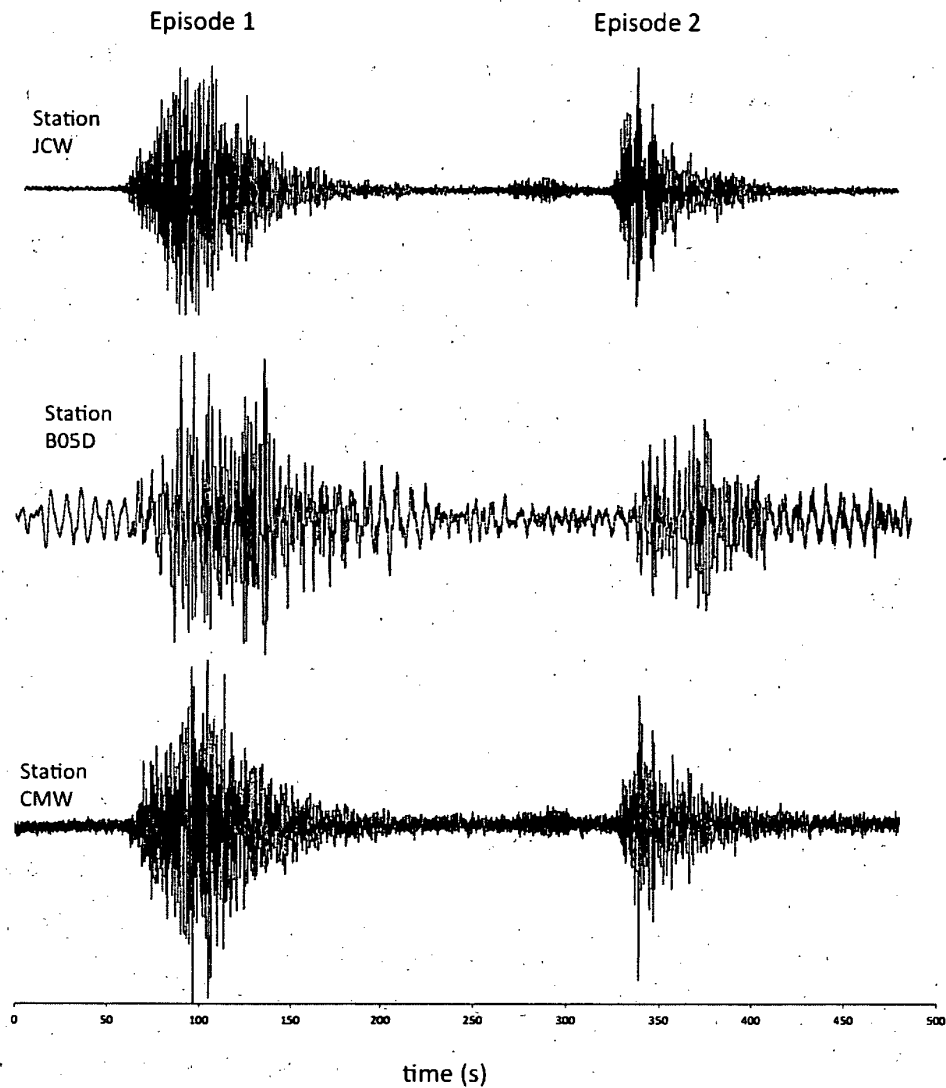
Figure 5.4.1 Velocity-time histories generated by the Oso Landslide. The signals were recorded at seismic stations located within approximately 22 km of the landslide site. A minor baseline correction was made to the signals, which are otherwise unmodified. Velocity values (vertical axis) have been normalized to facilitate a general comparison of the three signals; they are thus relative rather than absolute.

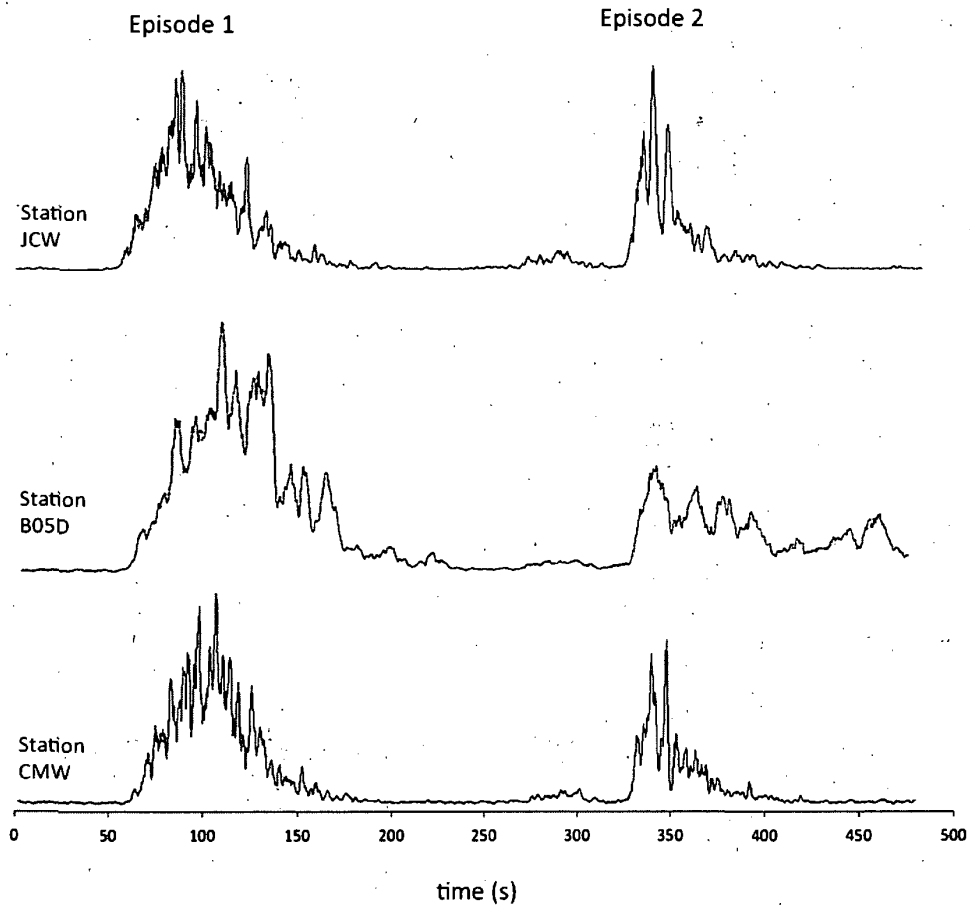
Figure 5.4.2: Landslide-generated velocity-time histories presented plotted as smoothed, high-pass filtered (<1 Hz), smoothed envelopes. Owing to the smoothing function, the velocity amplitude data (vertical axis) is relative rather than absolute.

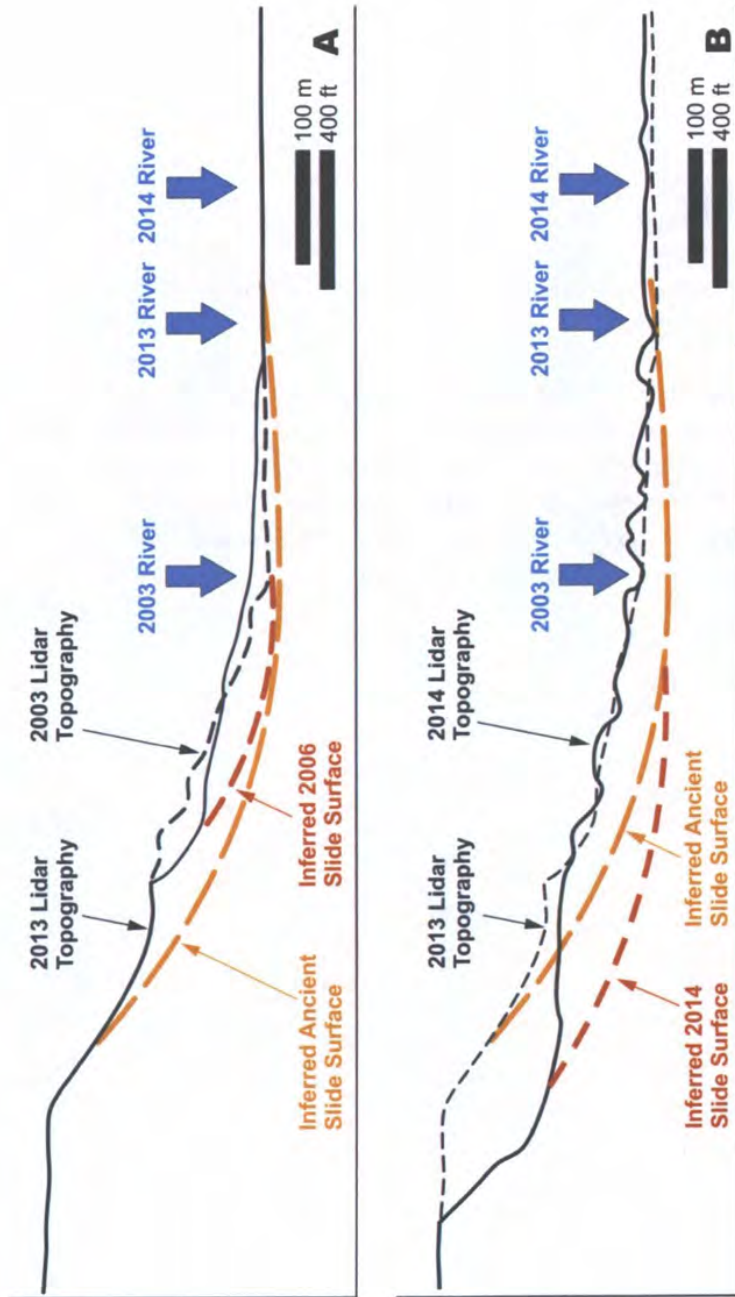
Figure 6.1.1: Schematic cross section (modified from A-A' from Figure 4.1.8) showing conceptualized 2006 and ancient slide surfaces (upper diagram). Also shown is a conceptualized 2014 slide surface (lower diagram).

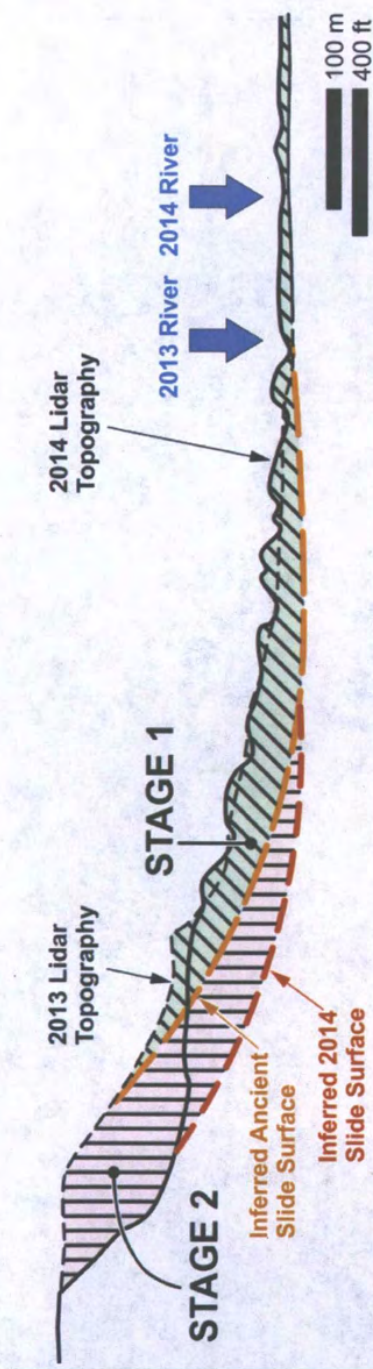
The first major stage of movement (Stage 1) is interpreted to be a remobilization of the 2006 slide mass and a headward extension that included part of the forested slope of the pre-historic slide. As such, Stage 1 was comprised largely or entirely of previous landslide deposits, some as recent as 2006, and others ancient. It is believed that Stage 1 initiated partly on a shear surface that is essentially the lower portion of the ancient slide surface, as is shown schematically in Figure 6.1.1, and mobilized as a debris flow, traveling across the valley and causing most or all of the damage and destruction south of the river.

The second stage (Stage 2) occurred subsequently in response to the unloading (i.e., loss of "buttressing") and the redirection of principal stresses and possibly, to groundwater seepage forces. Stage 2 was a retrogression into the Whitman Bench of up to nearly 90 m (300 feet) horizontally from the ancient slide scarp. The Stage 2 slip surface probably joined the slip surface of Stage 1 (and that of the 2006 and ancient slides) at depth, but also included up to 300 m (1000 feet) or more of previously deeper in-place outwash, till and lacustrine deposits (Figure 6.1.1). The Stage 2 landslide moved rapidly on the existing Stage 1 slip surface until it essentially collided with the more intact blocks at the trailing edge of the Stage 1 slide mass, and came to rest. The seismic signals show several much smaller events in the time following Stage 1 and these are included as part of Stage 2 in the discussion that follows. Stages 1 and 2 are shown schematically in section in Figure 6.1.2, and in plan view in Figure 6.1.3.

Figure 6.1.2 Schematic cross section (modified from A-A' from Figure 4.1.8) with conceptualized boundaries of Stage 1 and Stage 2 shown by hatch marks. Stage 1 evolved to be essentially a remobilization to the prehistoric slide surface. Stage 2 mobilized the material between the prehistoric slide surface and the 2014 slide surface.
