Geotechnical Extreme Events Reconnaissance

July 22, 2014

The 22 March 2014 Oso Landslide, Snohomish County, Washington

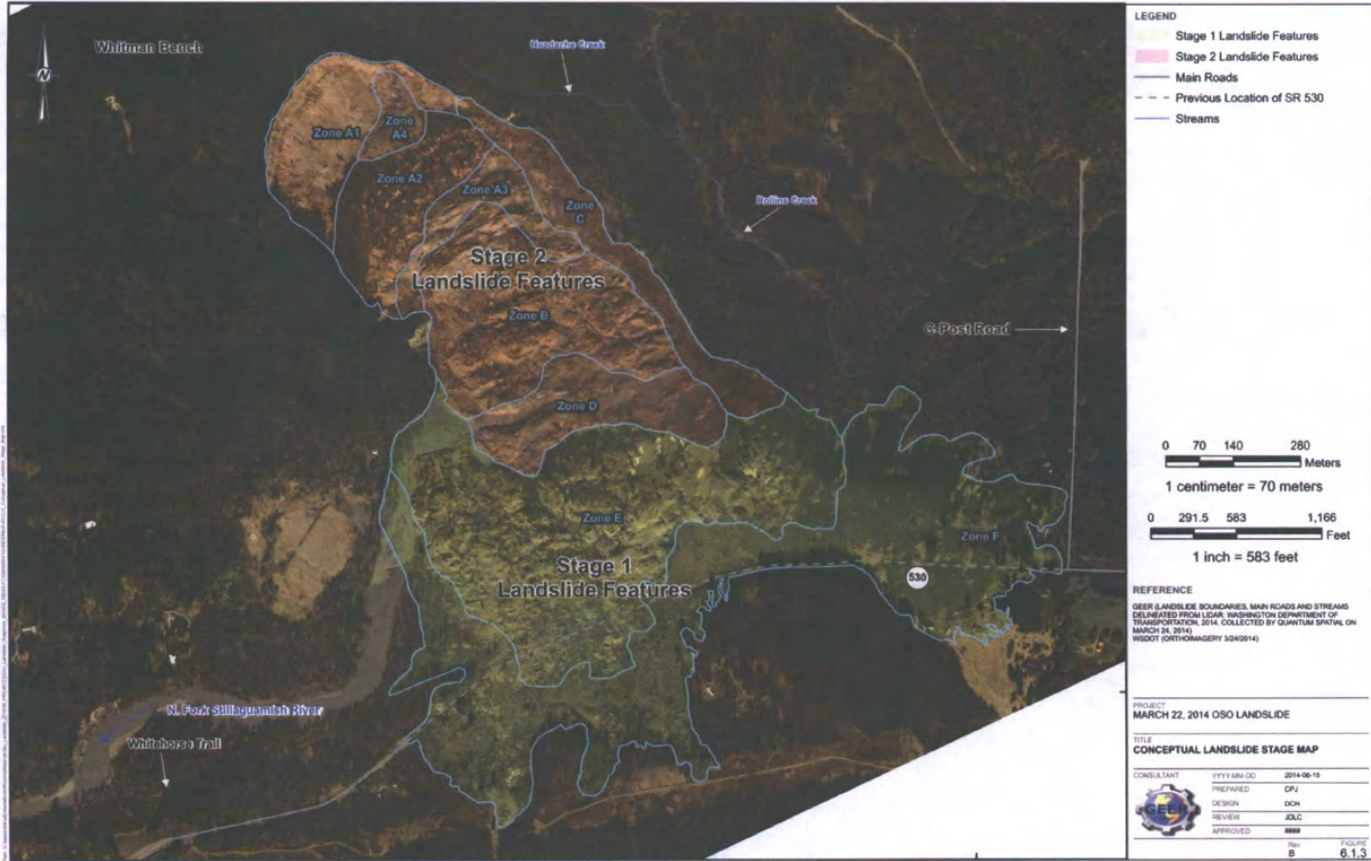
Figure 6.1.3. Conceptual landslide stage map.

With respect to the mechanism of movement, Stage 2 can be subdivided into four types and areas. The upper part of Stage 2 underwent no more than 700 feet (210 m) of lateral movement and rotated backward as a slump block so that the ground surface is largely intact and all trees have fallen and been laid flat by the downward acceleration or the back rotation and stopping of the block. This area has a classic slump-block morphology and the stratigraphy of recessional outwash over till appears largely intact (Zone A2 and A3 in Figure 5.3.1; Figure 6.1.3). Note that the till appears to have been a little more mobile and to have travelled farther downslope near the east margin, as can be seen in Figure 5.3.1 (Figure 6.1.3).

The upper middle part has an extensional morphology with back rotation evident by ground surface slopes, exposure of repeating stratigraphy, slickensides, and, in one location shown in Figure 5.3.8b, the skid marks left by fallen trees are clearly inscribed upon a slope. The lower middle part of the Stage 2 slide mass shows more signs of extension, including thinning of the outwash cover, and less back rotation of slump blocks. The area of extension is the lower part of Zone B as shown in Figure 5.3.1 (Figure 6.1.3).

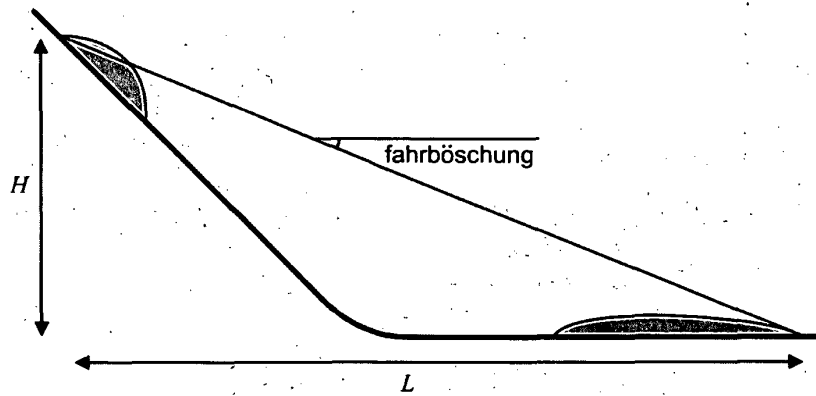
Figure 7.2.1 Definition of angle of reach or fahrböschung (after McDougall, 2006).

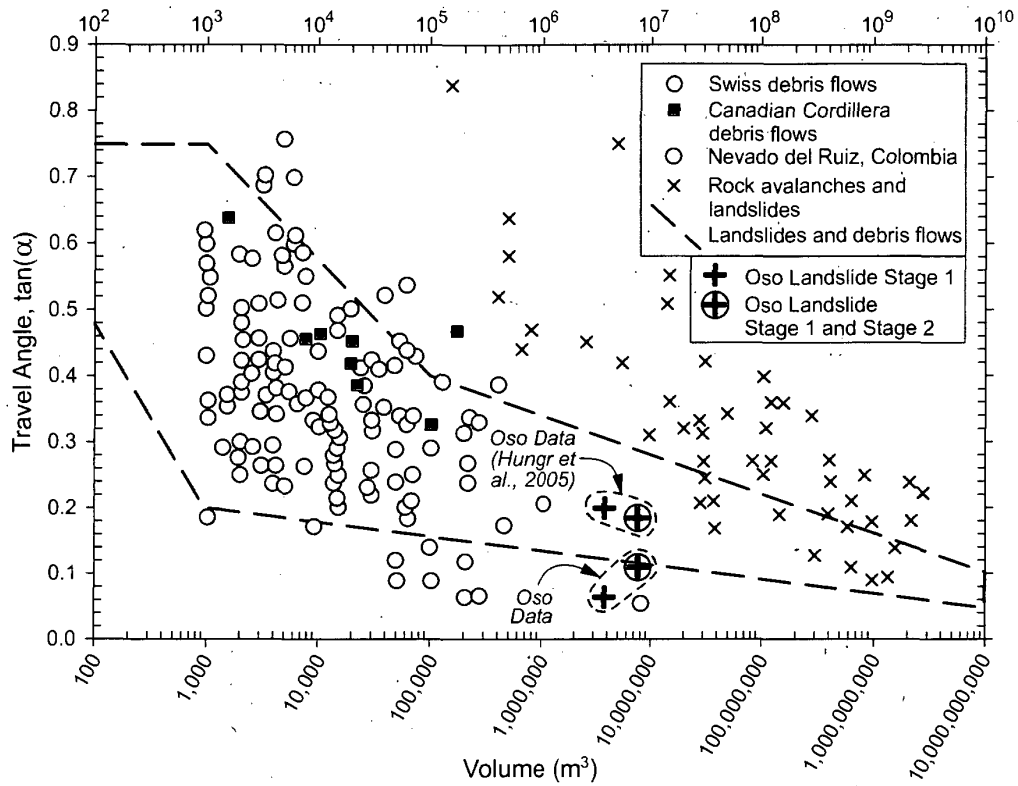
Figure 7.2.2 Travel Angle versus Volume of Mass Movement (adapted from Jakob and Hungr 2005). The data represented in this figure is from various case histories including debris flows, debris avalanches, rock falls and landslides. The travel angle for the Oso Landslide was estimated using the empirical relationship of Hungr et al. (2005) for debris flows using the total volume of the Oso slide and using 50% of the total volume. The lower data points are the travel angles based on the landslide height, H and the horizontal distance from the headscarp to the distal edge, L measured at Oso for the total volume and for 50% of the total volume of the slide.

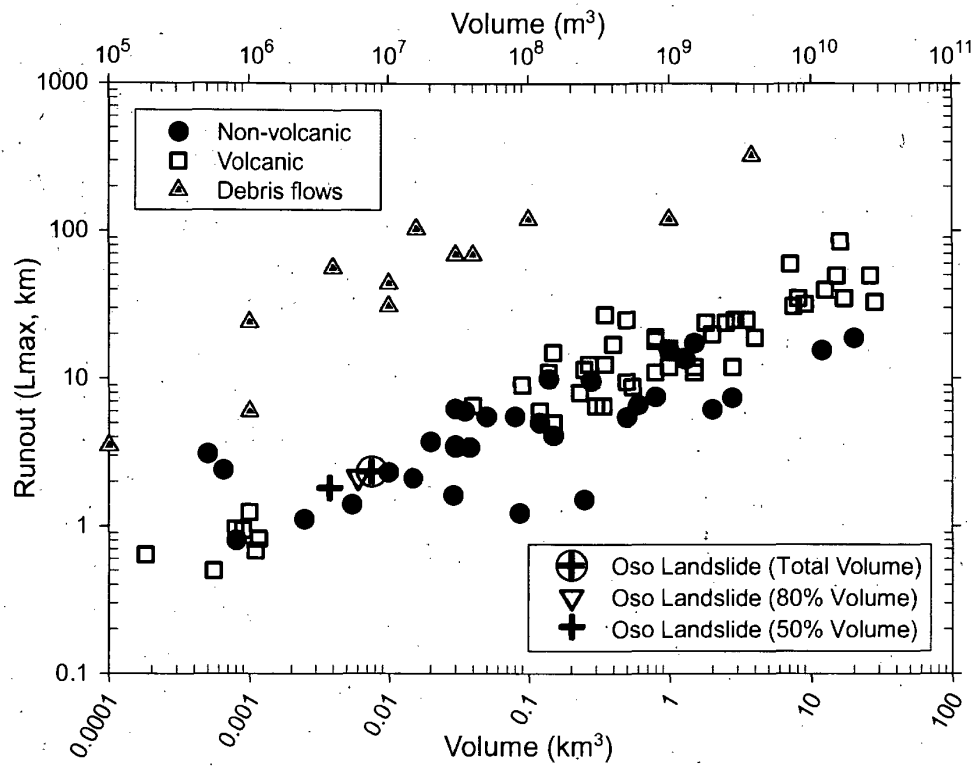
Figure 7.2.3 Relationship between volume and runout distance (after Legros, 2002):

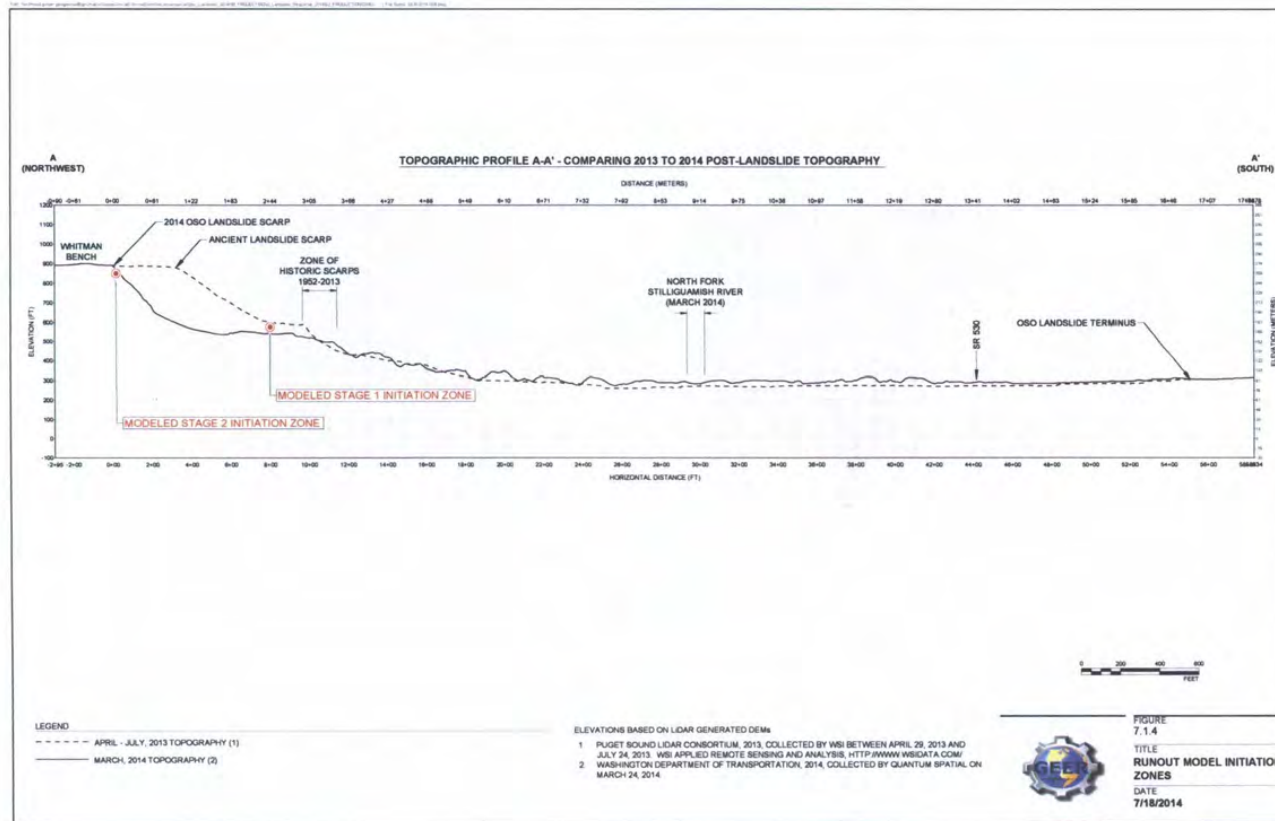
Figure 7.2.4 Profile showing starting locations for Stage 1 and Stage 2 events at Oso.

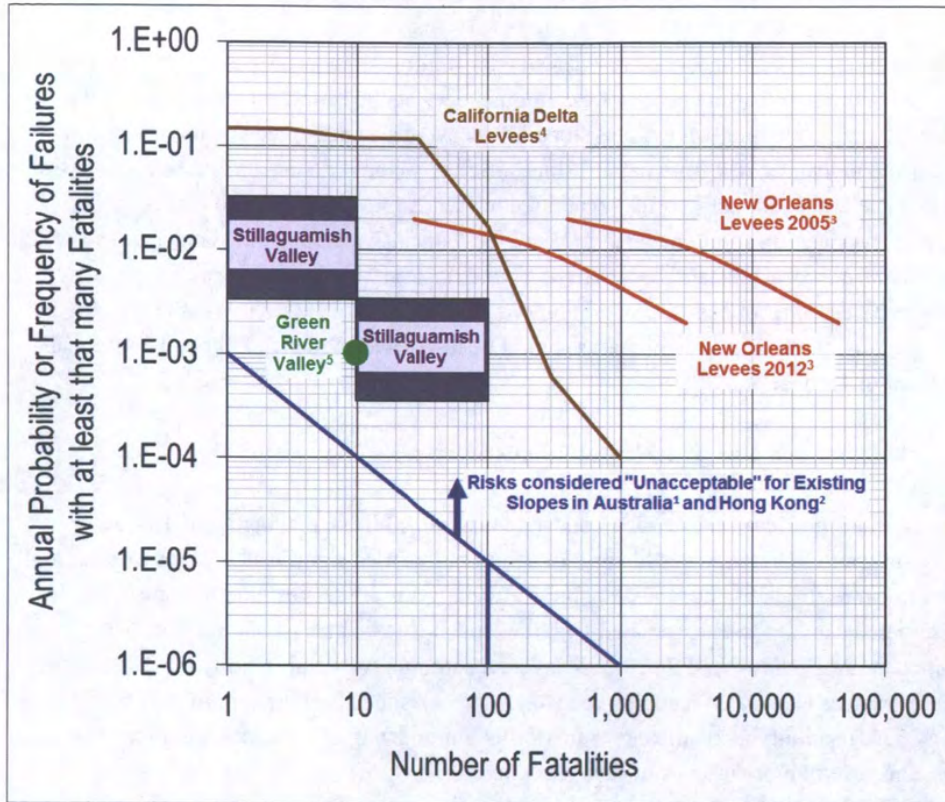
The rough assessments of failure probabilities for different human safety consequences are plotted in Figure 7.5.1 for this 5-km stretch of the valley. This plot shows the annual probabilities for different events versus the consequences of those events; both probabilities and consequences are expressed as order-of-magnitude ranges due to the limited information used to assess them.

No national or state guidelines exist in the United States for levels of risk due to natural landslides that warrant action. However, several benchmarks exist for the risk to human safety that provide informational context for the risk in this 5-km stretch of valley; these benchmarks are included in Figure 7.5.1 for comparison.

One benchmark is for natural slopes in other developed countries. For example, Hong Kong (GEO 1998) and Australia (AGS 2000) have recommended guidelines for risk levels that warrant action to reduce the risk. If this valley were located in one of these countries, then action to reduce the risk would be considered warranted (Figure 7.5.1). However, neither of these countries have the same legal system or regulatory system as the United States.

A second benchmark is the level of risk associated with major flood-protection systems in the United States (IPET 2009 and DWR 2008). This information provides context for what we are achieving in this country for a related natural hazard that is more regulated than natural landslides. The risk to human safety due to natural landslides in this valley is smaller than what exists for two major levee systems, one in California and one in New Orleans (Figure 7.5.1), primarily because the population at risk in the North Fork Stillaguamish River Valley is smaller.

A fourth benchmark is for major dams in the United States. The United States Bureau of Reclamation has established guidelines for risk levels that warrant action to reduce the risk in order to prioritize resources for remediating existing dams (USBR 2003). While the USBR (2003) risk thresholds are expressed in a way that cannot be plotted directly on Figure 7.5.1, they are similar to those shown on the figure for existing slopes in Australia and Hong Kong. If the risk in

this valley were due to a major dam rather than natural landslides, then “justification to take expedited action to reduce the risk” would be warranted (USBR 2003). However, this natural slope is not an engineered facility like a dam. In addition, the risk from a dam is to some extent imposed by society on the people living downstream from the dam in contrast to a risk that is accepted voluntarily.

Figure 7.5.1 Rough approximation of risk from landslides in 5-km stretch of North Fork Stillaguamish River Valley in vicinity of Oso compared with related benchmarks for human safety risk (¹AGS 2000; ²GEO 1998; ³IPET 2009; ⁴DWR 2008; ⁵Gilbert 2013).
